# Network Rail Operations Staff RTC 06/12/2015 M27

**Date:** 06/12/2015

**Location:** M27 Between Jcn 1 and 2 near Southampton

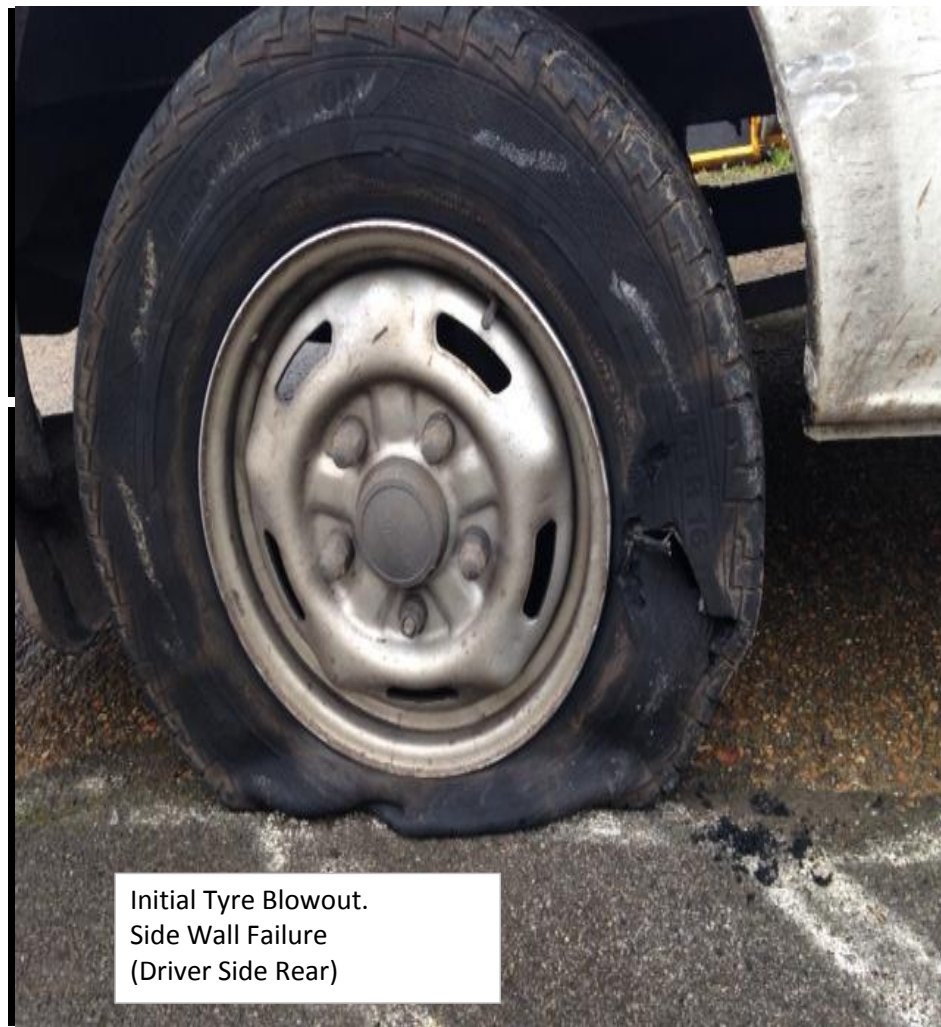
Initial Tyre Blowout.  
Side Wall Failure  
(Driver Side Rear)

**Rear Driver's side tyre blow out**

**Underlying Causes:** Possible Side wall of Tyre Faulty or damaged

- Although Vehicle checks are taking place, - Staff must use the daily inspection pre use sheets to record the inspections or the pre - use app rather than just the vehicle log book.

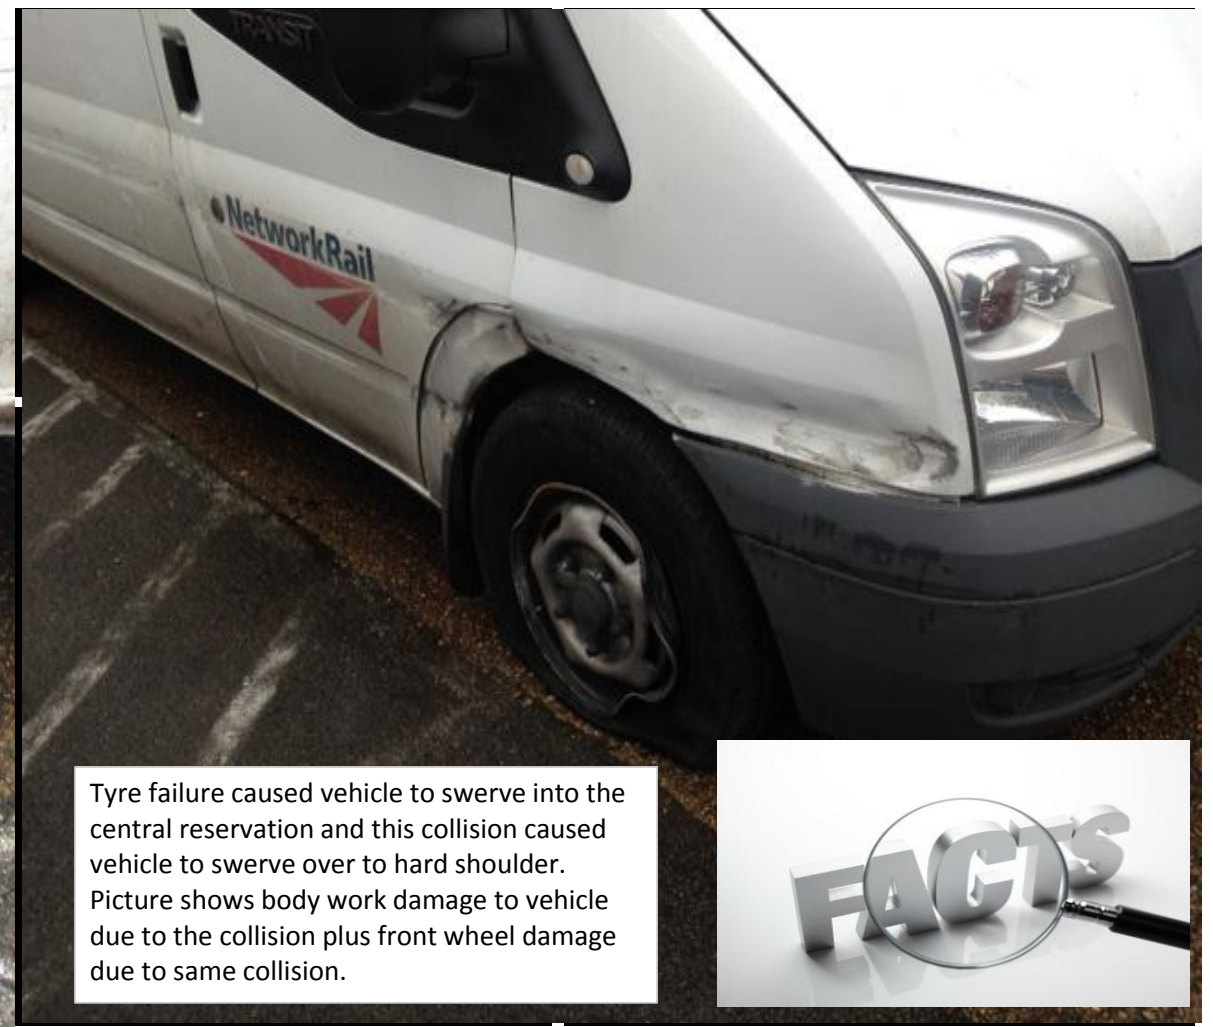
Tyre failure caused vehicle to swerve into the central reservation and this collision caused vehicle to swerve over to hard shoulder. Picture shows body work damage to vehicle due to the collision plus front wheel damage due to same collision.

Staff were travelling back from site at the end of their shift. Whilst travelling on the M27 motorway, the rear driver's side tyre blew out causing the vehicle to veer towards the central reservation. The vehicle collided with the Armco and this collision caused the vehicle to then veer towards the hard shoulder where the driver managed to bring the vehicle to a halt. The vehicle had been inspected before the journey started and no defects were reported. The vehicle had been MOT'd a month previously. The tyres are all relatively new looking.
