Re: Safety advice 04/12/2015

Robel 62.05 Vertical Tamper Inspection

Ser No: 62.05-0788K

Torrent Asset Number: T127 936

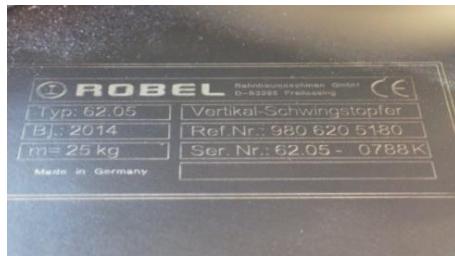
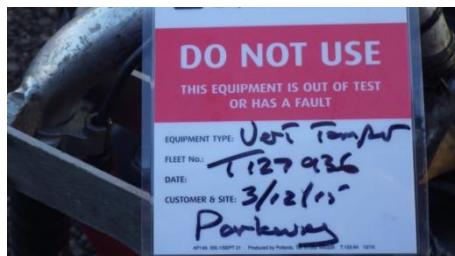
Initial inspection found that the engine had become detached from the machine at the joint between the Kawasaki Engine crank case and the Robel Fan housing.

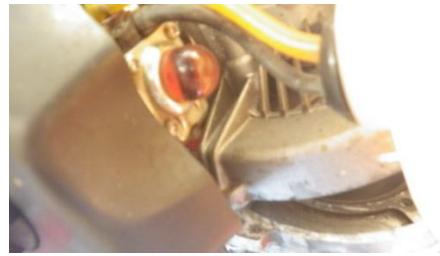
During inspection it was noted that the Kawasaki Crank case and the Robel Fan housings were of the correct type were intact and showed no signs of cracks.

The centrifugal clutch was also intact; the clutch spring was in place however stretched.

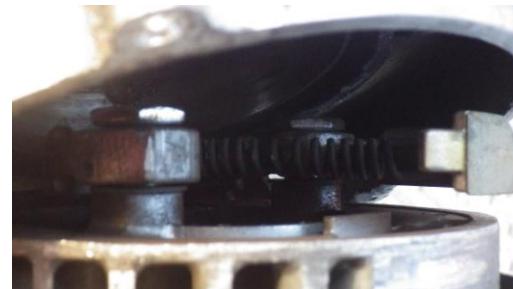
One of the screws that secure the Crank Case and Fan housings was found loose under the Engine cover.

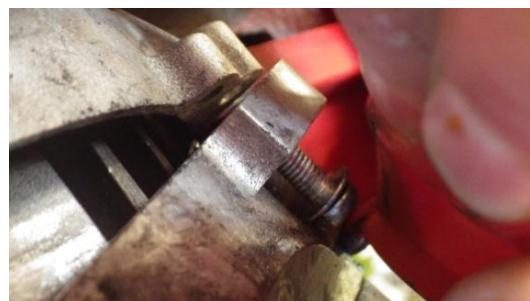
On closer inspection it was noted that this screw was too short for the application and the threads had stripped due to insufficient thread insertion.

Cause of failure incorrect screw used for application, possibly not torqued and no signs of screw locking medium.

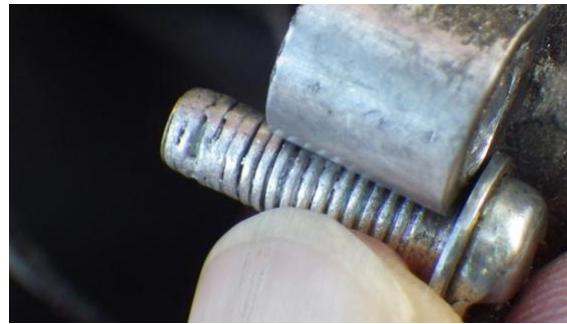
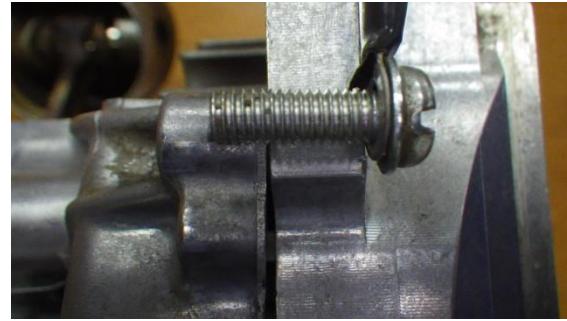
Incorrect Screw - too short for application (M5x16).

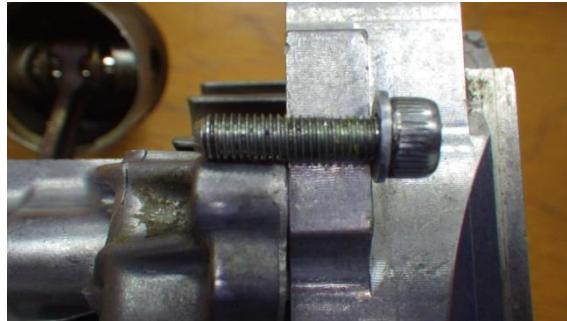
Correct Screw for application (M5x20)
