STEL Ironman Tie /Gauge Bar Failure

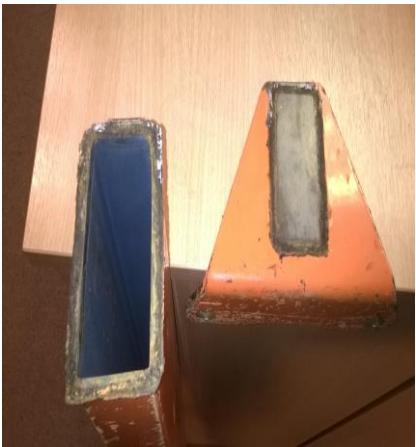
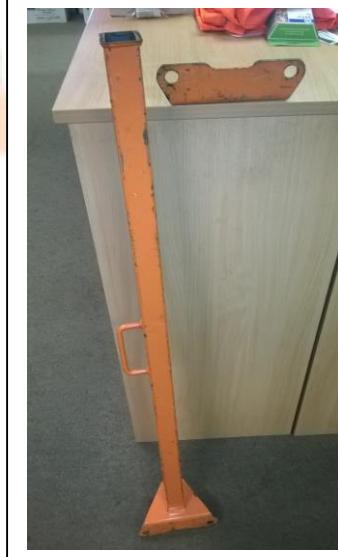
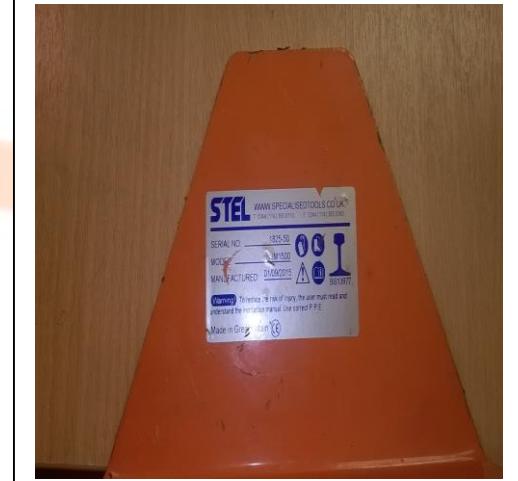
The weld holding fixing plate to the tie bar has failed and in turn de-stabilises the Ironman with the potential for collapse or de-rail. Early indications suggest that the weld has not fully taken hence a weakness and the failure. This equipment was supplied new at the beginning of December 2015

It is strongly recommend that robust inspection regimes are undertaken prior to use of any Iron Man and all associated component parts and in particular the Tie/Gauge Bar

IT IS SUGGESTED THAT STOCK IS CHECKED AS A MATTER OF URGENCY
