Safety - summary of selected incidents

Week ending 25/08/2016

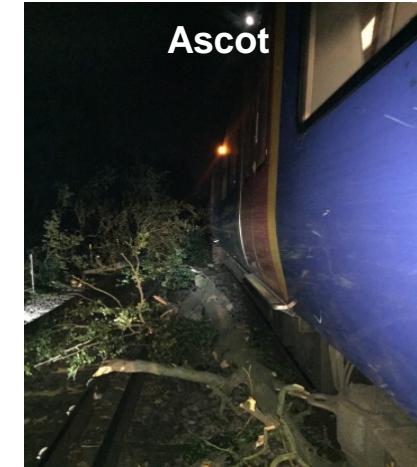
- ▶ WX – A passenger train struck a large fallen tree obstructing both lines near Ascot (line speed 70 mph). The train did not derail and there were no reported injuries. Parts of the tree were wedged underneath the train and there was also damage to points, track and conductor rail.
