Infrastructure Projects Southern

Home Safe

The Southern Region's Weekly Safety Update

12 October 2016

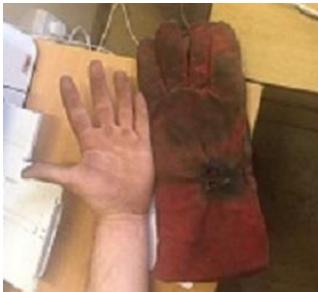
A contractor was burning out sheared bolts on a bridge structure in South Yorkshire when molten metal burnt through the palm of their leather gauntlet. As a result, they suffered minor burns to their forearm and wrist.

The leather gauntlet being worn was the Warrior Red Split Leather Welding Gauntlet (0111WRSC).

Personal Protective Equipment should be the last line of defence against harm. All PPE must be CE marked and made to relevant standards. [You can view the full bulletin here.](#)

If PPE or equipment is not fit for purpose, or you suspect it not to be genuine, report it.
