Infrastructure Projects Southern

# Home Safe

The Southern Region's Weekly Safety Update

19 October 2016

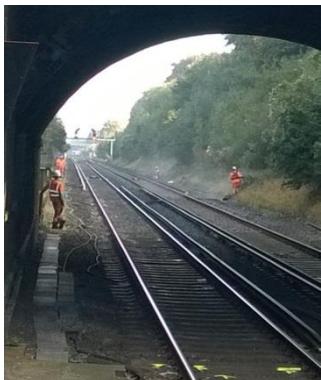
Whilst undertaking lineside de-vegetation at Burgess Hill, a complaint was received as to the Safe System of Work (SSOW) being used. A Mobile Operations Manager attended site and checked the SSOW pack.

The pack identified the work as being planned within a Separated Green Zone using Site Wardens to keep staff a minimum of two metres from the adjacent line. The incident is currently under investigation.

- Are the operatives shown in the photograph a minimum of two metres from the open lines?
- Where are the Site Wardens protecting the operatives working on the right hand cess?
- How would the operatives using the strimmer on the right hand cess be warned by a Site Warden if he is getting too close to the 2m point?
- Is the operative using the strimmer on the right hand cess working safely on a slope adjacent to an open line and a live conductor rail?
- How is the 2m point measured and identified to those working?
- Is it acceptable to use a limited clearance without a suitable SSOW to gain access to the site of work?
- Is it safe working so close to a live conductor rail?
- How are operatives crossing from one side to the other?
