Home Safe

The Southern Region's Weekly Safety Update

16 November 2016

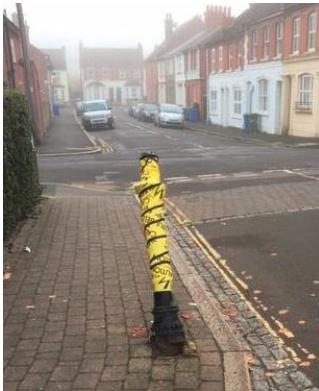
Lorry collides with lamp post

A low loader lorry driver was delivering an RRV to Aldershot maintenance depot when it reversed into a lamp post. The lorry was having to reverse as the access gate to the station was locked.

Initial investigations into the accident suggest that the driver relied on an operative to assist him when reversing. It appears that the operative did not signal to stop the lorry as the lamp post was in his blind spot. This resulted in the trailer colliding with the post. [You can find a copy of the full bulletin here.](#)

- All deliveries should be pre-planned and overseen by a suitably competent person.
- Reversing of commercial vehicles should not be undertaken without a competent banksman /traffic marshal.
- The driver and banksman /traffic marshal must ensure communications between them are agreed prior to carrying out any manoeuvre.
- The banksman/traffic marshal is to remain visible to the driver at all times.
