Shared Learning

Displaced ASDO beacon at Wimbledon

Date of issue: 17/10/2016

Location: Wimbledon

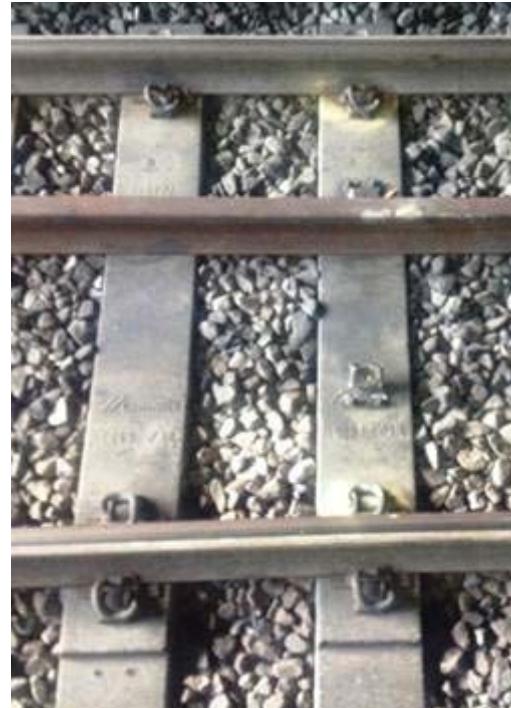
The ASDO system failed to detect the beacon in platform 7.

On inspection by response staff it was discovered that one of the ASDO beacons within the platform was missing.

Are all teams aware of the criticality of ASDO beacons and what to do if they are found to be damaged or missing?

When CWR rail is dropped are we ensuring that Rail is not in the vicinity of ASDO beacons and is being inspected for movement on a regular basis

When undertaking works are your teams aware of the requirement to re-install any beacons in the correct position.
