Shared Learning

Short circuit bar irregularity at Fulwell Junction

Ref: P03 1617

Location: Fulwell Junction

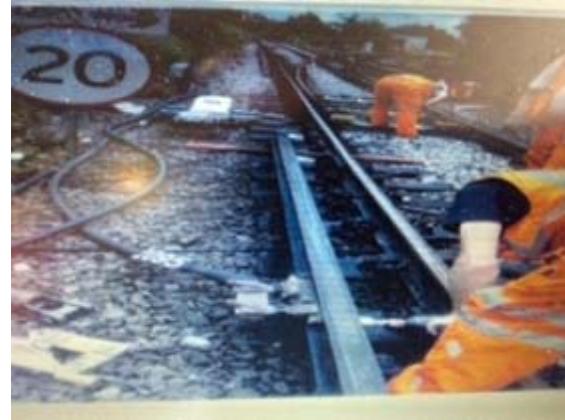
Whilst working on a number of faults in a short notice temporary isolation, a member of the CRE team fitted a short circuit bar in the wrong location, which caused the circuit breaker at Fulwell to trip.

The CRE team was working on hook switch 2095 and under the electrical control operators instruction had fitted two bars, one either side of the fault. The con rail had been tested and a bar fitted next to the hook switch, the CRE team member then went to the other end of what he believed to be the correct cable and applied the short circuit bar. This was in the wrong location, as the other end of the cable was on the up Shepperton and not the up Shepperton spur which was not part of the isolation.

- The short circuit bar had been fitted onto the Up Shepperton Spur vice the Up Shepperton road.
- The hook switch had been tested and the first short circuit bar fitted, however, the Person In Charge of the Temporary Isolation (PICTI) had failed to test the other end of the conductor rail prior to fitting the second short circuit bar.

- Test before touch - Never assume equipment is isolated.
- Always test before applying earths or straps
