Home Safe

The Southern Region's Weekly Safety Update

14 December 2016

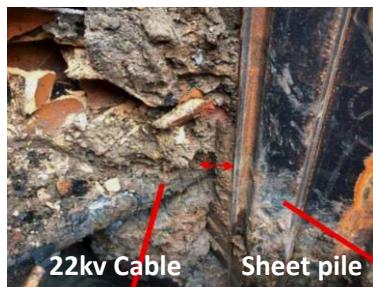
HV cable Close Call

Whilst carrying out drainage connection works for Thameslink, a 22kv cable was discovered close to where the sheet piles had been installed.

The sheet piles were over two metres below the ground level and the services drawing attached to the permit to dig showed a HV cable at a depth of 750mm; however, the team had not located this during their progressive scanning and sheet piling. They had uncovered another cable which was 11kv and thought this was the only HV cable.

In order to fit the pipe into the sewer, the operatives cleared the bottom of the trench. It was during this clearance that the team became aware of the 22kv cable. The cable was approximately 20mm from the edge of the trench sheets that had been installed. *You can find a [copy of the full bulletin here](#).*

Where services are indicated on service drawings but not found by those undertaking the works, safe digging practices must be followed until the presence of the services are confirmed.
