Infrastructure Projects Southern *Home Safe*

The Southern Region's Weekly Safety Update

25 January 2017

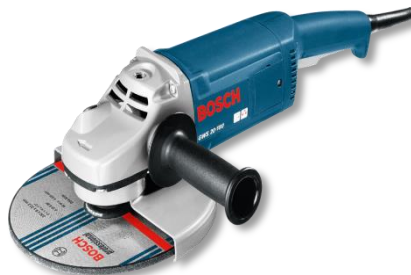
A recall notice has been issued after Bosch Power Tools discovered that, due to a faulty component, the cutting or grinding disc together with the fastening fixture (spindle) could become detached during operation on a limited number of their angle grinders. Bosch have advised that, with immediate effect, angle grinders with specific models and serial numbers should no longer be used or provided to others.

Further details of the recall including the affected serial numbers and models can be found [here](#).

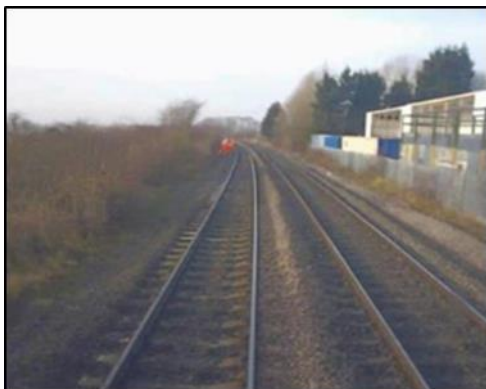
Near Miss at Saxby

On Monday 5 December an eight man team consisting of a Network Rail Safe Work Leader (SWL) and seven subcontractors were digging out wet beds on the up main line near Saxby in Leicestershire.

The SWL set up a work site taking Line Blocks on the Up and Down Main lines.

A Kango that had been used for the work was left in the six foot

on a high ballast shoulder. Vibrations caused by the freight train on the Down Main caused the tool to roll down the shoulder and come into contact with the six foot rail of the Up Main line. A Trackman stepped onto the track, to retrieve the Kango and stepped out again back into the position of safety just as a passenger train approached on the Up main around a curve at 90mph.
