Wessex Route

Welcome to your Health, Safety and Environment Cascade for Period 10 2016. This contains all the documents and safety briefs for you and your teams this period. Flick through this document and share as a team, print off the pages that you want to discuss and pin them up in mess rooms for staff to look at throughout the month.

Title: Slip and Fall in icy conditions in Eastleigh Depot Yard: Broken Arm.

Slip Whilst Removing Fishplate Bolts: Neck Injury

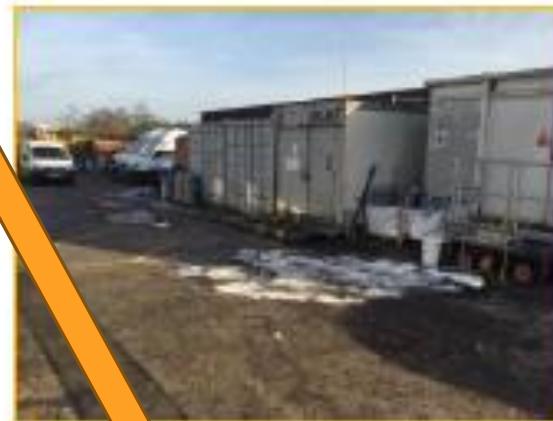
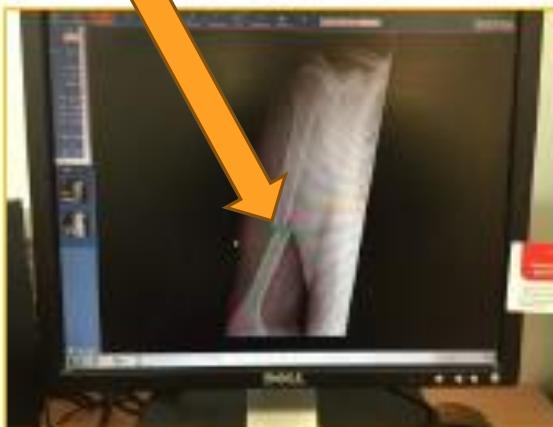
On 3rd January at 0740 hours, a member of staff working for Works Delivery Signalling Section slipped and fell over in exceptionally icy underfoot conditions. He sustained a nasty break to a bone in his right arm. (Humerous)

At the time he had walked out of the building and noticed a large patch of ice which he had placed a red fence around to warn others, he had then walked across the yard to the plant store to get salt to apply to the ice patch (The white salted area in the photo).

However before he could collect the rock salt to put on the ice, he walked back around the ice patch; it seems that he misjudged the slippery surface edge. He was wearing safety boots which were correctly fastened, but lost traction on the slippery surface; his feet went from underneath him. He put his hand and arm out to catch himself but as he came down he landed on his upper arm and shoulder, and he heard the crunch as his arm was damaged.

The front of the entrance of the Depot yard had been treated already but not the rest of the yard / compound where it had happened.

The area has been reported to Property Hotline as water is known to gather at this particular spot.

1. During these very cold weather conditions all areas of Depot yards must be regularly treated with Rock salt or similar anti-ice treatments.
2. Areas known for gathering water should be closely monitored whilst waiting for action and if Property Action does not respond in a timely manner escalate the complaint.
3. During icy conditions make sure we have sufficient rock salt or similar anti-ice treatments available and use liberally;
 - At the depot
 - On or near the vehicles
 - Access Gates and steps
 - Taken to site.

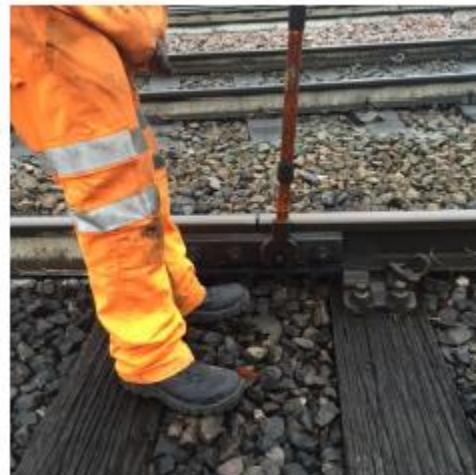
On 4th of December 2016 at 01.30 hrs on the BAE1 at 82m 35ch, at Salisbury Tunnel Junction, a P/Way Operative from Salisbury depot sustained a neck injury whilst undoing a Fishplate bolt. Weather conditions were extremely cold at the time.

The injured party (IP) was part of an 8 man team carrying out track maintenance and was tasked with removing a Fishplate. As he applied pressure the spanner slipped off the nut causing the IP to fall backwards.

1. Make sure when using handheld tools they are correctly and firmly fitted to the component being worked on.
2. When stood on ballast removing or replacing components where some pressure needs to be applied ensure that a firm footing is established and avoid standing on sleepers.
3. When working during inclement weather conditions;
 - take that little extra time to clear your work area of any potential slip hazards.
 - Keep warm to minimise risks of pulled muscles

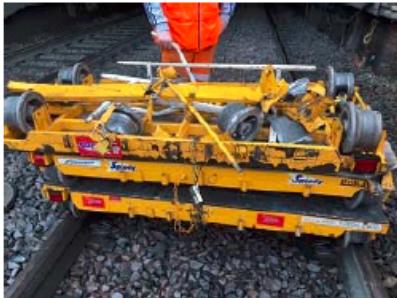
Plant and equipment stored in tunnels

On Thursday 1 December temporary lighting that was left lineside in Balcombe tunnel after track renewals four weeks earlier was caught by a train, damaging a track circuit cable and causing significant performance impact. The lighting was moved by vibration or turbulence from passing trains. Investigation found the equipment left in the tunnel included a full petrol can.

On Thursday 8 December one of four portable permanent way trolleys that were temporarily stacked in Stowe Hill tunnel after work the previous night was moved by vibration or turbulence and one was struck by a train. The train had a broken window and bodyside damage.

In each case, the contractors involved had not properly secured the equipment left in the tunnel and had not adequately considered and mitigated the risk of damage, fire or derailment.

The Infrastructure Plant Manual (NR/PLANT/0200/module P505) requires that all small items of plant or accessories are left securely after work.

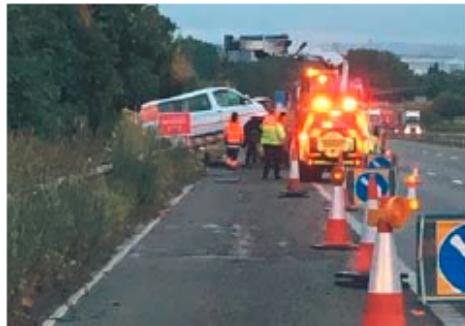
Serious road accident on M5

At 04:47 on 29 July 2016 a Ford 9-seater minibus left the north bound carriageway of the M5 between Junctions 20 and 19 near Bristol and came to rest on the motorway verge.

An investigation has concluded that the immediate cause of the accident was that the driver fell asleep while driving.

The driver was fatigued from travelling between the work site and the team's home area near Cardiff, leading to him falling asleep whilst driving.

- All staff should have a minimum of 12 hours rest between shifts. Travelling to work sites counts as work time.
- Travelling time from base to worksite must be considered before allocating work. What can be done to ensure staff have sufficient rest between shifts?
- Door to door time must not be planned to exceed 14 hours. This needs to include picking up and dropping off team members.
- Planning must take account of fatigue management policies for every shift.
- Planning should identify and confirm designated driver(s) and, where necessary, hotel accommodation.
- Route and contractor assurance should test compliance with fatigue management policies and the Code of Conduct.

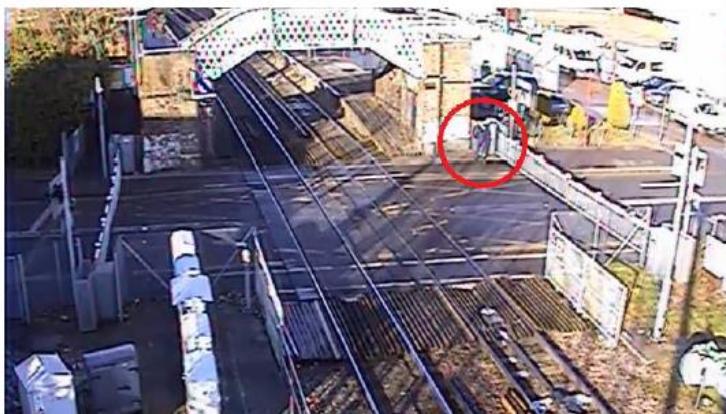
On Thursday 5th January, at approximately 12:25, the Signaller operating panel 4 at Feltham ASC initiated the lowering sequence at Chertsey CCTV level crossing for the passage of 2S25 which was approaching the crossing on Down line. The Signaller observed a member of the public (MOP) enter the crossing and stopped the lowering sequence, the MOP however did not exit the crossing and stood next to the down side facing boom pedestal. The Signaller attempted to raise the barriers but was unable to do so as he had already called a route from F301 signal which protects the level crossing on the Down line. It was not immediately clear to the signaller why the barriers would not raise, and whilst trying to raise the barriers he inadvertently operated the crossing clear button. F301 then cleared to a proceed aspect with the MOP inside the crossing, immediately after the crossing clear button was operated, the MOP then exited the crossing.

- The member of the public entered the crossing during the lowering sequence and failed to exit the crossing when the sequence was stopped.
- A route was set across the level crossing from F301 signal, the Signaller did not immediately recognise that this would prevent the barriers from raising when in manual.
- The Signaller inadvertently operated the crossing clear button with a member of the public within the limits of the crossing.

- Do you know that a route being set over a level crossing will then prevent the barriers from being raised manually?
- Are you aware that the protecting signal/s should only be cleared after you are sure the crossing is clear and the crossing clear button has been operated? (*National Operating Instructions, Unit 29, Section 6.2*)
