IMDM OUTER

Slip Whilst Removing Fishplate Bolts: Neck Injury

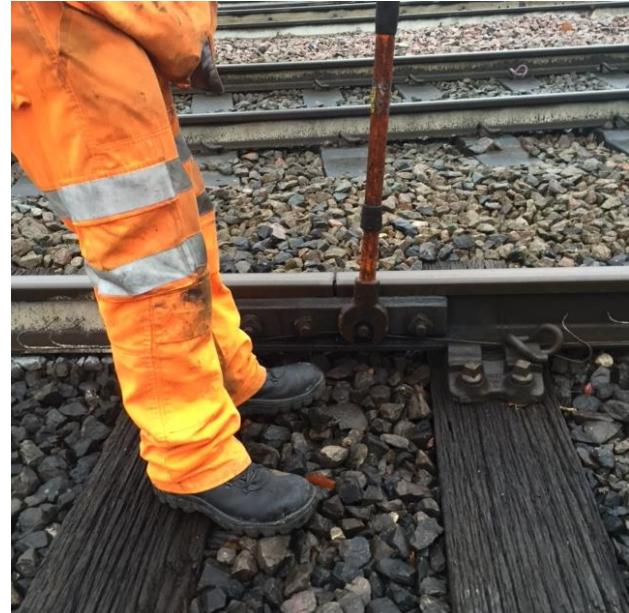
On 4th of December 2016 at 01.30 hrs on the BAE1 at 82m 35ch, at Salisbury Tunnel Junction, a P/Way Operative from Salisbury depot sustained a neck injury whilst undoing a Fishplate bolt. Weather conditions were extremely cold at the time.

The injured party (IP) was part of an 8 man team carrying out track maintenance and was tasked with removing a Fishplate. As he applied pressure the spanner slipped off the nut causing the IP to fall backwards.

1. Make sure when using handheld tools they are correctly and firmly fitted to the component being worked on.
2. When stood on ballast removing or replacing components where some pressure needs to be applied ensure that a firm footing is established and avoid standing on sleepers.
3. When working during inclement weather conditions;
 - take that little extra time to clear your work area of any potential slip hazards.
 - Keep warm to minimise risks of pulled muscles
