Sharing Lessons Learnt

RIDDOR at Redhill Platform 0

20 January 2017

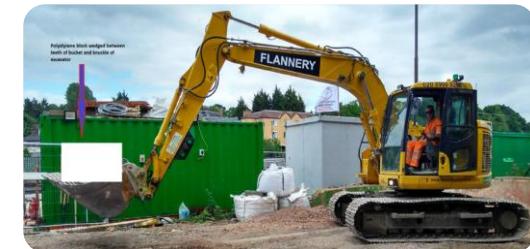
As part of the construction of the new platform, 60 kg Expanded Polystyrene (EPS) blocks were being lowered using a 25Te 360 excavator to their point of installation at a lower level. During the lowering operation, one of these blocks rolled forward from the excavator's bucket striking an individual on the head and knocking him to the ground. The individual sustained three fractured vertebrae as a result.

The individual was standing in an unsafe area adjacent to the lifting operation. Always ensure an effective exclusion zone is in place and being effectively managed and that loads are secure before lifting.

Never enter the agreed exclusion zone, unless directed to by the person in charge.
