Infrastructure Projects Southern

Home Safe

The Southern Region's Weekly Safety Update

10 January 2018

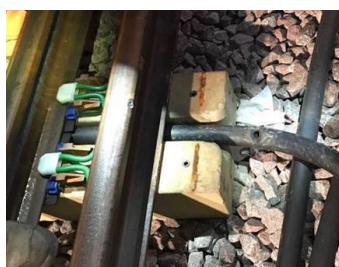
A track team tasked with moving lengths of rail next to an out of use line, were utilising two RRVs. These were fitted with lifting chain attachments to tandem lift a 60ft length of rail which had been left on the sleeper ends adjacent to the track. During the task the Crane Controller directed the Machine Operator to lower the machine's jib

for the lift and as the chain attached to the jib came into contact with the rail, it created an electrical circuit causing an arc and flashover. The Crane Controller suffered suspected arc eye from the flashover.

The loose rail had vibrated onto the ballast and had comprised the sheaf of an energised traction cable sitting on the ballast.

- Detailed site surveys should be carried out prior to storing rail in 'out of use' areas as operational cables may be present.
- Due consideration and robust planning should be made when storing materials/equipment in the railway environment.
- Operational cables should be identified and marked accordingly.
- The detailed [Shared Learning and actions taken can be found here](#).

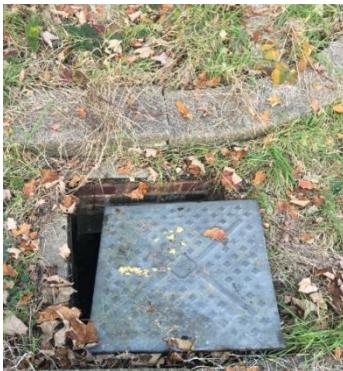
An operative working for the supervisory controls project sustained a leg injury whilst surveying external cable routes at Penge sub-station. As he walked in an area covered in leaves, he stood on a cable chamber manhole cover which gave way beneath him. One of his legs plunged down the chamber to waist depth resulting in an injury to his right knee. He was taken to hospital where it was confirmed he had suffered serious ligament/tendon trauma, bruising and fluid accumulation to his knee.

- Always ensure that that you replace manhole covers correctly and test to check it is securely fitted in its frame.
- Always report (and Close Call) any missing, damaged or ill-fitting covers to the responsible owner/maintainer and make them safe or indicate there is a hazard before leaving site.
- Be aware that leaf fall and vegetation can hide hazards in the ground. In this particular case, the hazard of the incorrectly fitted cover was exacerbated by a covering layer of fallen leaves following recent high winds.

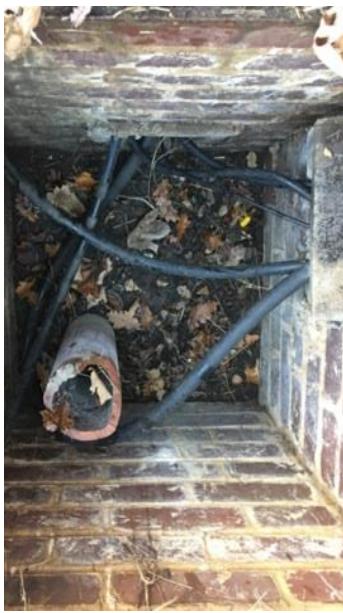
The manhole cover was refitted, tested and found to be in good condition. It transpired that the manhole cover had not been fitted properly by previous users which resulted in the cover not being seated correctly in its frame. This caused it to tilt when weight was applied. This accident was recorded as an over seven day RIDDOR event.

A Close Call was also raised to remove a sharp, broken pipe from the cable chamber. Fortunately, the injured person had fallen on the opposite side to this pipe and did not come into contact with it. Had he done so, his injuries could have been even more serious.
