Transferable Lessons from Serious Operational Incidents / Investigations

**Issue No:****NR/OPS/024****Date Issued:****22/06/2018**

Management of Bridge Strikes

**Bridge 86, Stoke Road, Stoke-on-Trent****Summary of incident:**

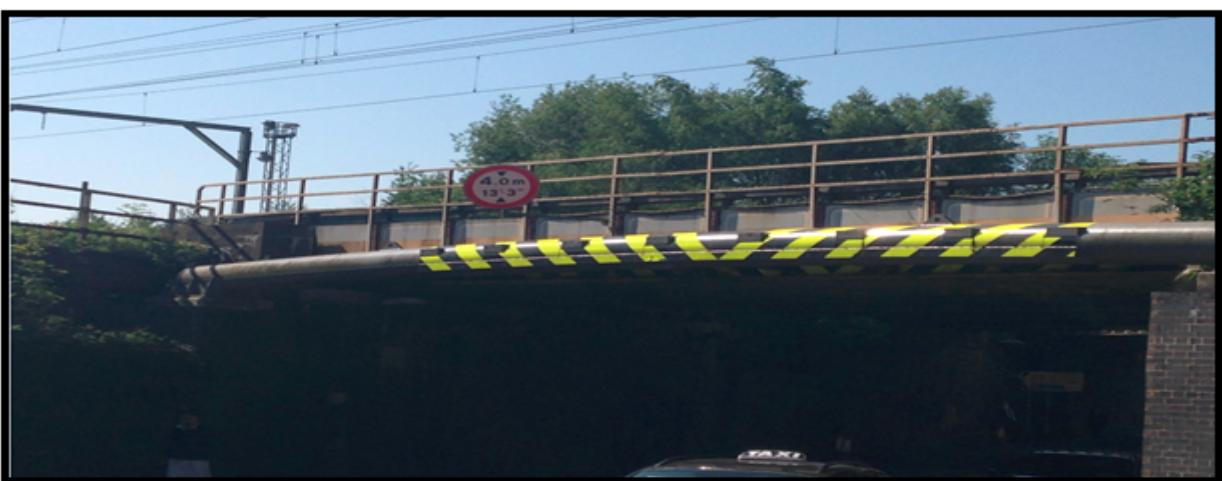
On the 18 May 2018 a curtain sided Heavy Goods Vehicle (HGV) collided with bridge 86, Stoke Road, Stoke-on-Trent. As a direct result of the impact, the Shift Signaller Manager (SSM) based at Stoke-on-Trent (SOT) Signalling Control Centre (SCC), located in the vicinity of bridge 86, heard the collision and exited the SCC to investigate.

The SSM observed that the HGV had hit the collision protection beam only and authorised trains to continue to proceed at line speed over bridge 86; although the Signal Box Special Instructions (SBSI) advised a double amber dispensation must be implemented.
