Transferable Lessons from Serious Operational Incidents / Investigations

Issue No:	NR/OPS/026	Date Issued:	30/05/2018
-----------	------------	--------------	------------

Points run through during pilotworking at Evesham

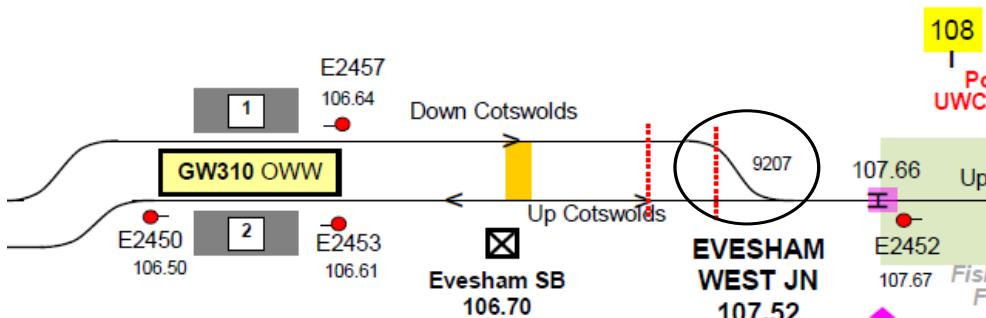
The pilotman on board 5W10 observed that the points were not in the correct position for the train movement and told the driver to stop the train. The train came to a stand with the front bogie on the points causing a partial points run through.

The signaller was eager to keep delays to a minimum, and this meant that a quick decision was made to change the position of 9207 point in error.

There was a lack of clear understanding of the exact position of 5W10, in relation to both 9207 points and where the engineering works were taking place.

By taking 5 this will allow you to take your time to fully check any degraded working on your panel/workstation.

Ensure a clear understanding of exact train location before points are moved. This was captured by an updated method of working. The pilotman is now instructed to contact the signaller once the train was beyond E2452 CWTL. The signaller would then set the route for the next move back towards the station.
