Transferable Lessons from Serious Operational Incidents / Investigations

Issue No: NR/OPS/028

Line Blockage Irregularity at Eastfield SB

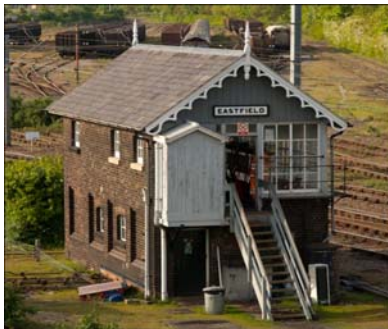
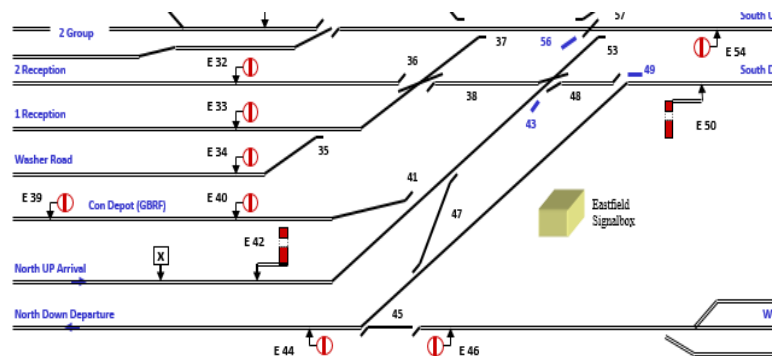
A broken fishplate was identified on both the North Down Departure and the North Up Arrival by a Network Rail maintenance team whilst patrolling. The COSS proceeded to the signal box to agree a line blockage details and limits. The COSS stated that the work would affect the safety of the line but the line blockage was granted without additional protection contrary to TS1 13.2. The signaller had provided signal protection and applied reminders to the slot lever and to the protecting signals.

- If the task cannot be performed safely, ensure that you do not allow it to happen.
- Always ensure that you follow the Rule Book requirements, TS1 13.2.4 clearly states 'The COSS, IWA, PC or SWL will also need additional protection to be provided if the work will affect the safety of the line'
