IMDM OUTER

Title: Scrap Rail in contact with 750 Traction cable **Scrap Rail discovered to be live**

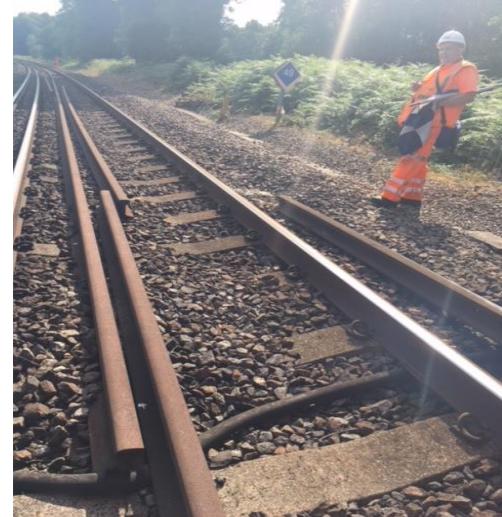
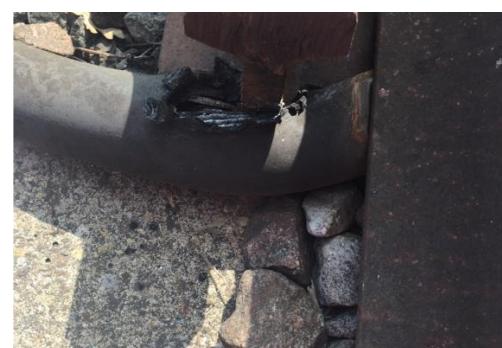
On the 19th of July at approx 10:13 hours, on the WPH1 at 49 m 00Ch a principle patroller from Havant Track found a damaged 750v traction cable, which was caused by a scrap piece of rail that had pressed up against it removing the insulation.

The scrap rail in contact with 750 Traction cable was discovered to be live, this could have caused electrocution or a fire if it had contacted a fuel source

The scrap rail had crept in the warm weather and had eroded away the insulation of a 750DC Traction cable.

With CWR in the 4ft not being held down by anything it has a tendency to creep especially in areas of gradients or heavy traffic because the vibration from passing trains can also have an effect. The rail had not been sat on saddles.

Re-brief track inspection staff that where we have long sections of CWR in the 4ft or on the ballast shoulder we must spray the rail ends to be able to monitor how much the rails are creeping during the summer months.
