# Rail Accident Report

**Near miss with a group of track workers at  
Egmanton level crossing, Nottinghamshire  
5 October 2017**

Report 11/2018  
August 2018

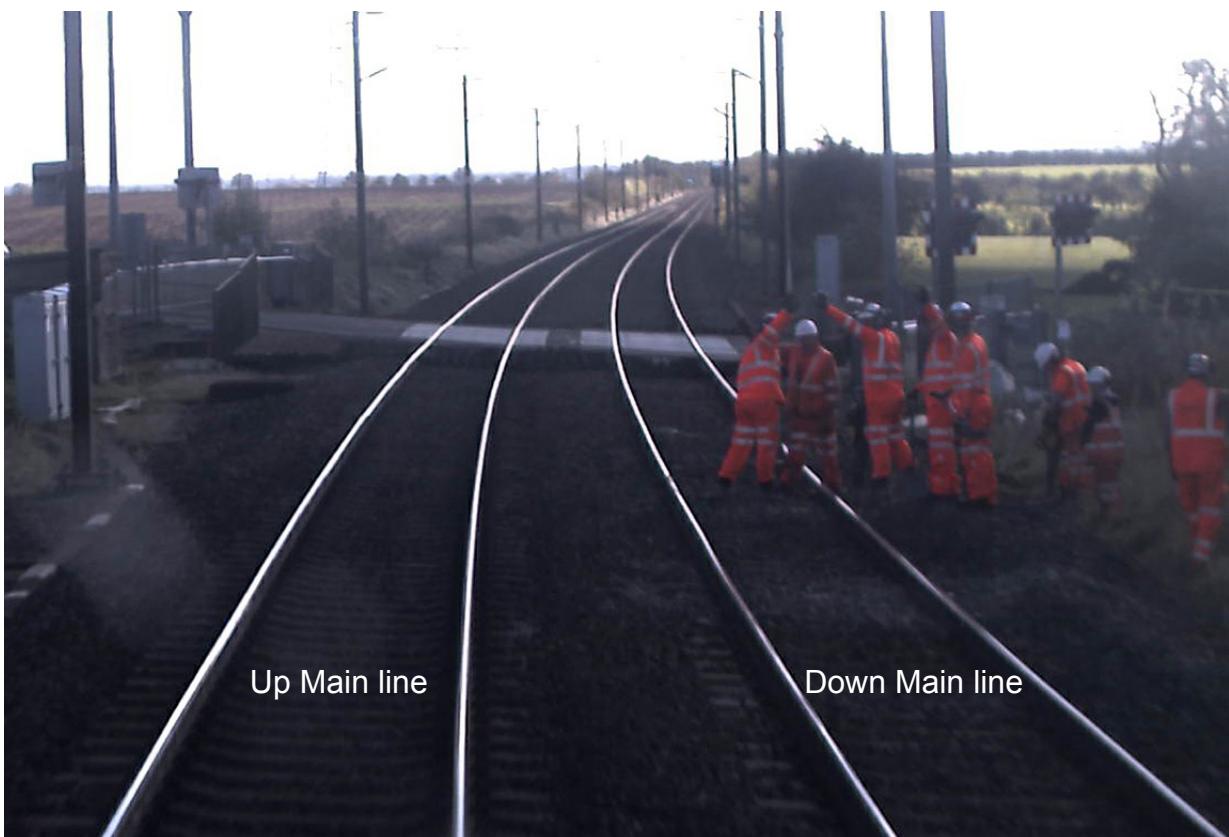
- 46 Around 20 seconds after the passage of this train, train 1E06 passed the group on the up line. The CCTV image from the front of train 1E06 shows that the group had recommenced work as soon as train 1S11 had passed (figure 4). At this time the TOWS warning tone would have continued to sound as both trains were present in the section.

Figure 4: Forward facing CCTV image from train 1E06 approaching the group on the Up Main line, captured 20 seconds after train 1S11 had passed them on the Down Main line (image courtesy of Virgin Trains East Coast)

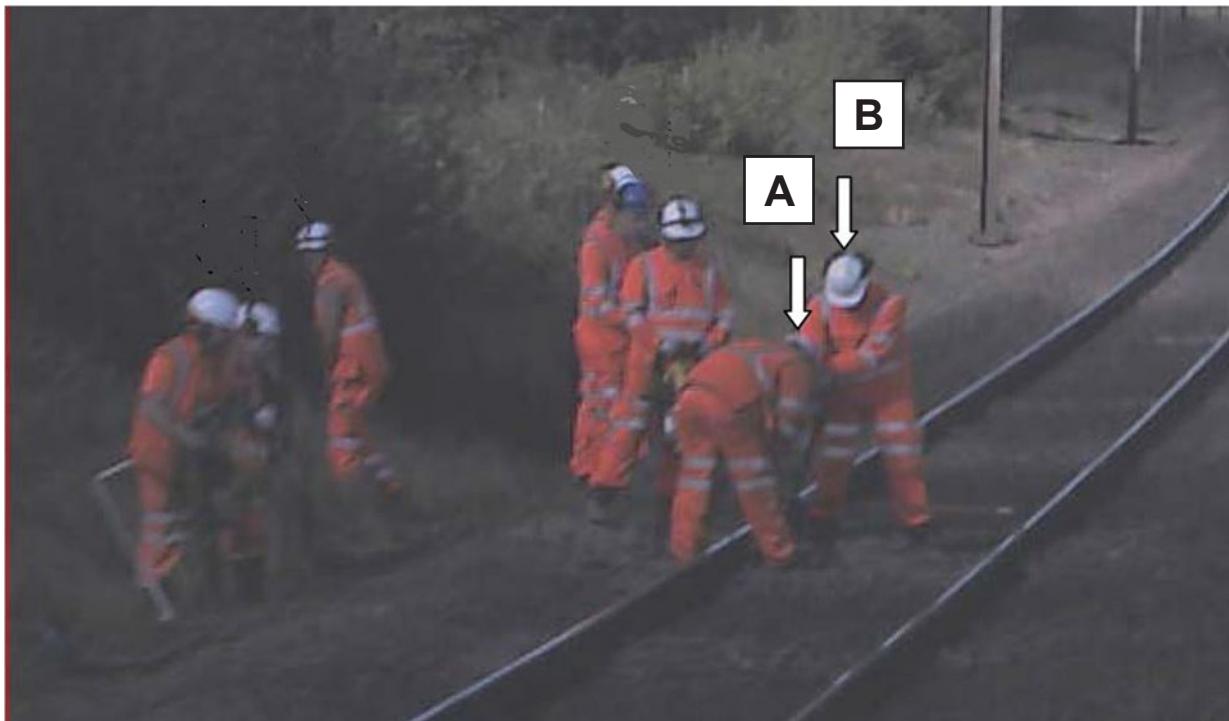
47 Train 1E06 was also fitted with a rear facing CCTV camera (figure 5). The RAIB has determined that the person marked 'A' in the image, is the PiC who is bending over to read a cross level gauge with his back to trains approaching in the down direction. The person marked 'B' is operating a track jack, and is the track worker whom the PiC appointed as the site lookout at the first site of work and who performed the lookout role later on at the second site of work (paragraph 41).

Figure 5: Rear facing CCTV image from train 1E06 passing the group on the Up Main line, showing the positions of the PiC ('A'), and the lookout ('B') (image courtesy of Virgin Trains East Coast)

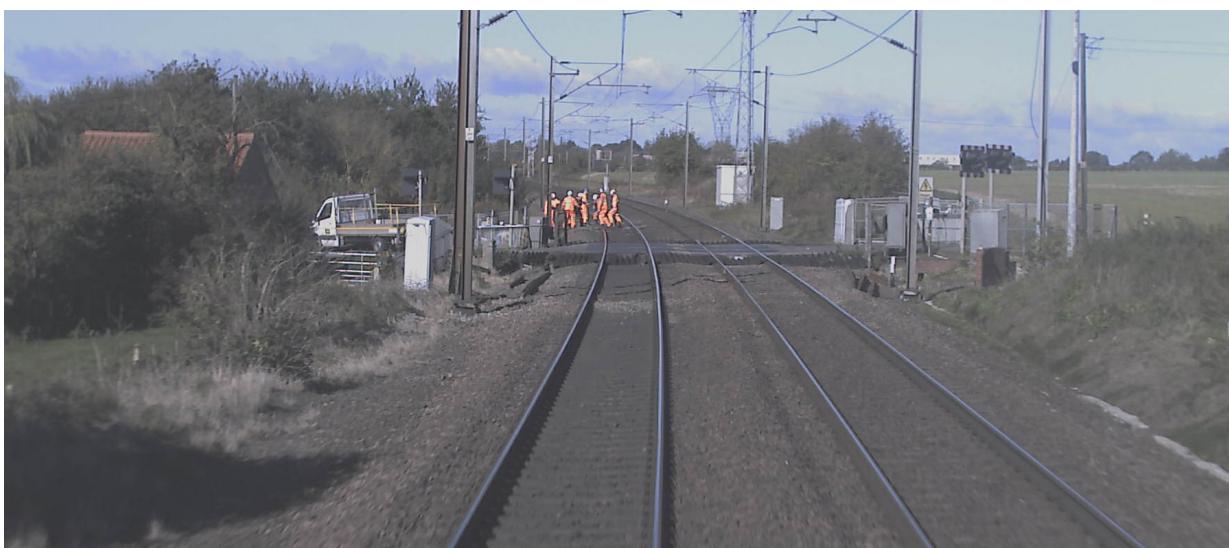
48 At around 11:22 hrs the work was nearly complete and TOWS began sounding the warning tone as train 1D09, the incident train, was approaching in the down direction (figure 6).

Figure 6: Forward facing CCTV image from train 1D09 showing three workers on the track as it approached the group on the Down Main line approximately 2 seconds before reaching the site of work (image courtesy of Virgin Trains East Coast)

52 Most of the group reported that they did not hear the train horn until a few seconds before the train reached the site of work. The driver told the RAIB that he sounded the horn twice on the approach, once when he first saw the group and then a continuous sounding of a series of short blasts from around nine seconds before reaching them. This is supported by evidence from the train's on-train data recorder (OTDR). The driver reported that after applying the emergency brake he closed his eyes as the train passed the site of work, expecting an impact.

53 It is likely that the track workers did not hear the horn earlier as, although the mechanised element of the work was complete, TOWS was sounding its warning, and some were still wearing ear defenders.

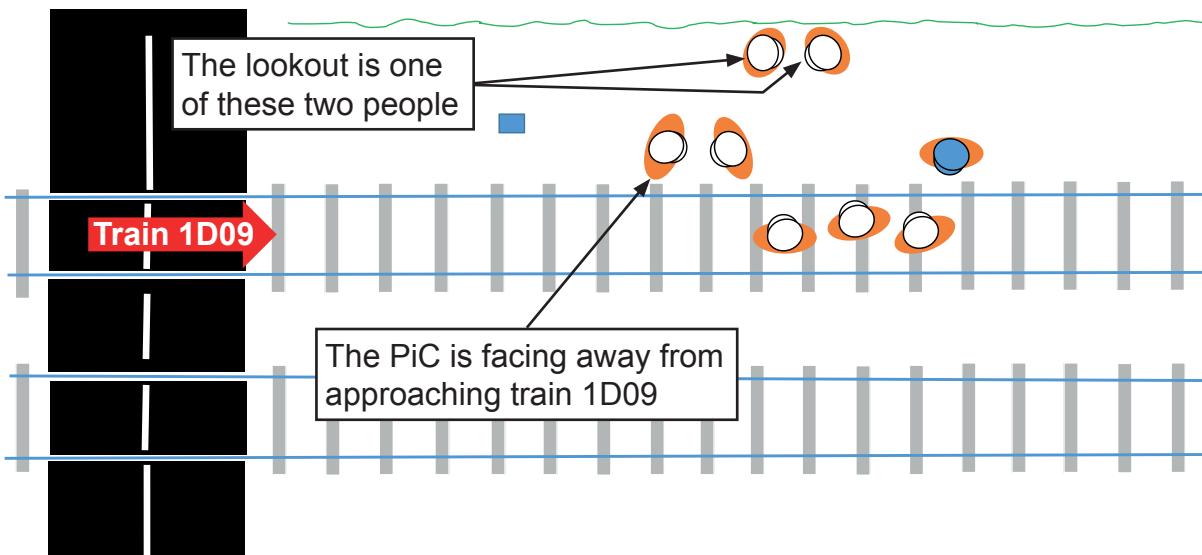
49 The approximate positions of the members of the group, and their actions immediately prior to the arrival of train 1D09, are based on witness evidence and forward facing CCTV images from this train (figure 7).

Figure 7: The approximate positions of the track workers immediately prior to the arrival of train 1D09

50 The PiC, who was standing close to the track with his back to the approaching train, told the RAIB that he was waiting for a down train to pass so that he could check that the track levelling work was satisfactory. Although accounts vary, it is likely that he was talking with one of the VHRL team who was facing the approaching train.

51 Four of the group had been on the track, clearing loose ballast from the top of the sleepers. One of them, who had been using a shovel, had moved clear leaving three on the track. The train's CCTV camera images indicate that around 5 seconds before the train arrived, one of them was crouching down, probably removing loose ballast with his hand. The track worker who was talking to the PiC and facing the approaching train shouted to the others when he saw it. This was around three seconds before the train arrived. The CCTV images show that the three workers on the track were clear of the track around one second before the train reached the site (figure 8).

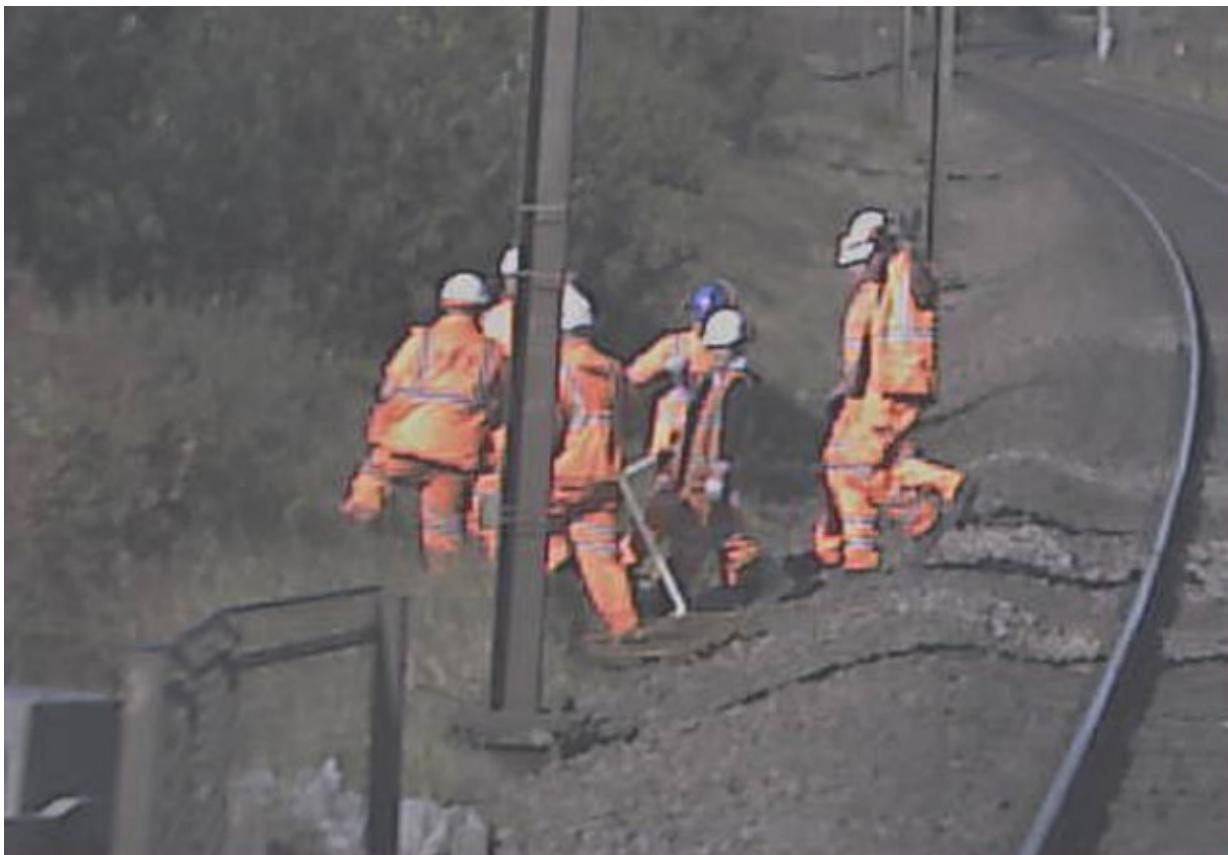
Figure 8: Forward facing CCTV image from train 1D09 showing the track workers moving clear of the train approximately one second before it passes them at 125 mph (201 km/h) (image courtesy of Virgin Trains East Coast)
