High Impact Infrastructure incidents

Wessex Route Asset Management
11 September 2018

RAM Structures High Impact incidents

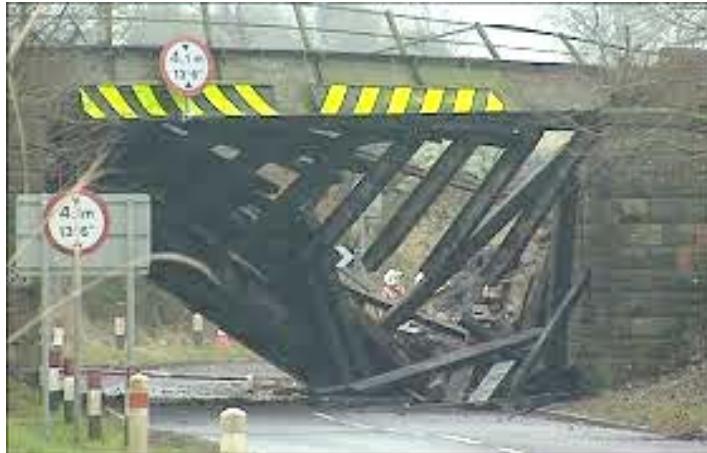
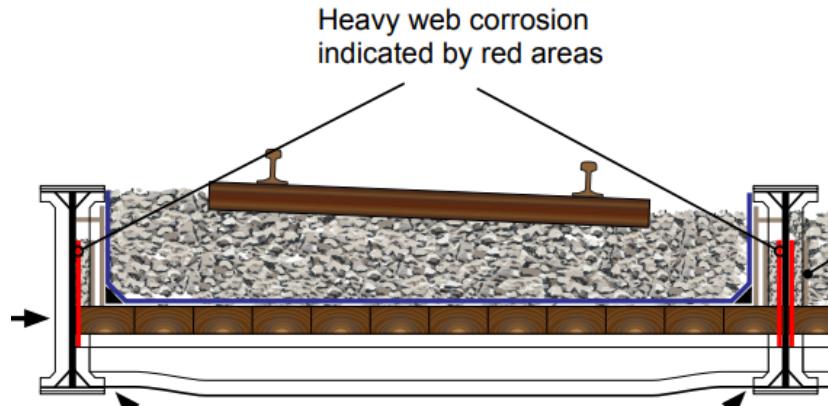
Stewarton, Scotland, 2011

Failure was caused by severe corrosion to hidden elements highlighted red above.

Since the failure, examination of these 'hidden elements' has been mandated at defined intervals. These examinations continue to highlight significant defects to our assets.

- Examination.

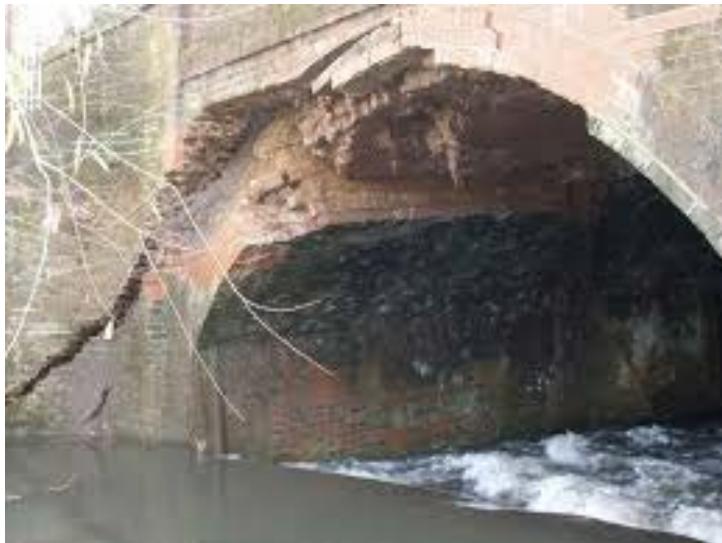
River Crane, Wessex, 2011

Both failures caused by the effect of scour action on the bridge foundations.

- Examination.
- Procedures for extreme weather.

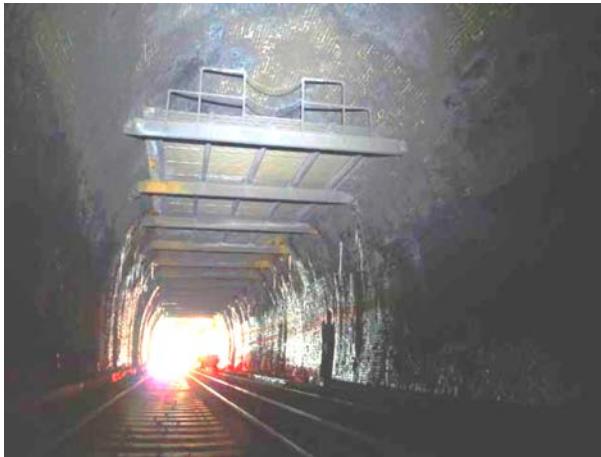
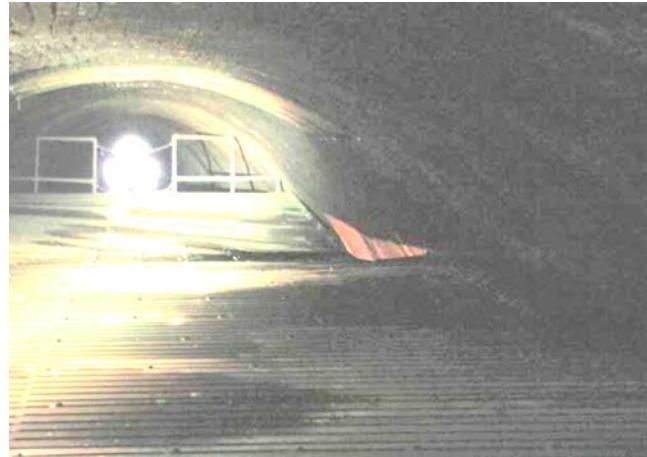
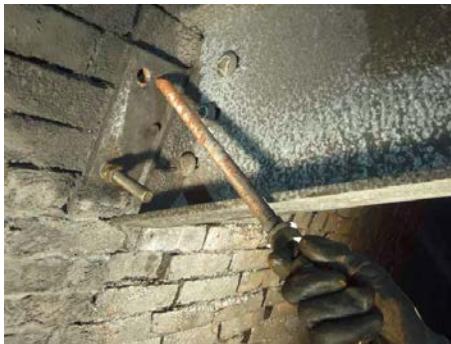
Balcombe, South-East, 2013

A partial collapse of the water-catchment system occurred due to failure of the anchors fixing into the tunnel lining.

- Examination
- Design

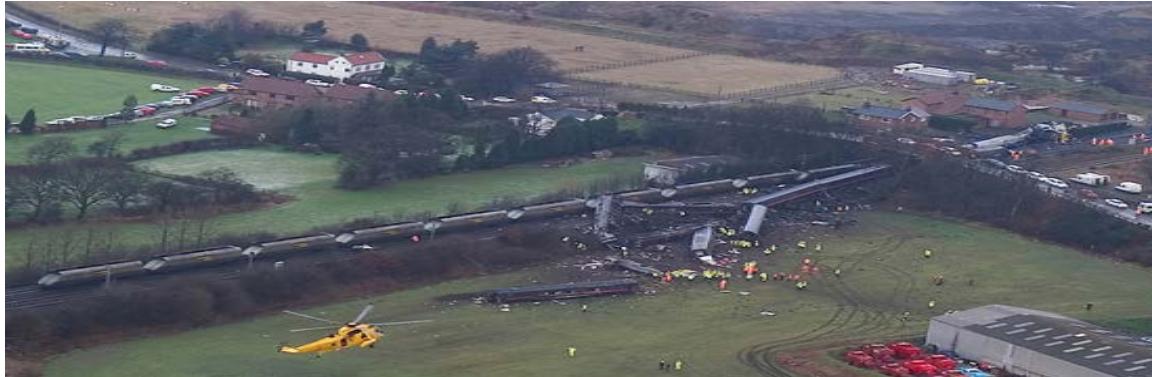
Great Heck, LNE, 2001

Ten people were killed at Great Heck when a vehicle came off a bridge onto the railway.

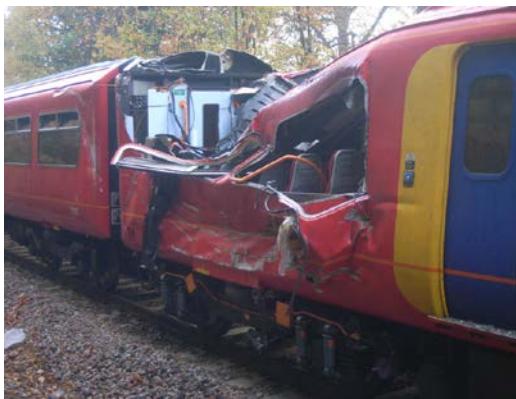
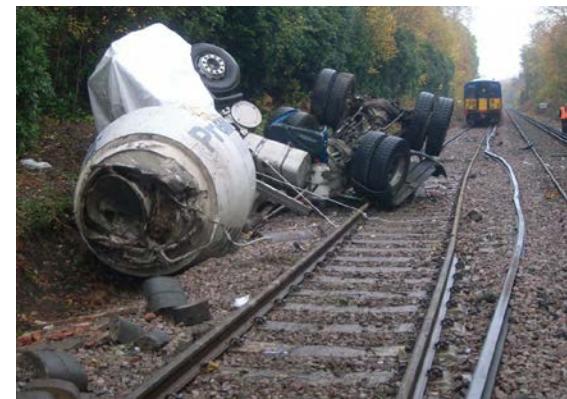
Oxshott, Wessex, 2010

At Oxshott, a cement lorry landed on the roof of a train.

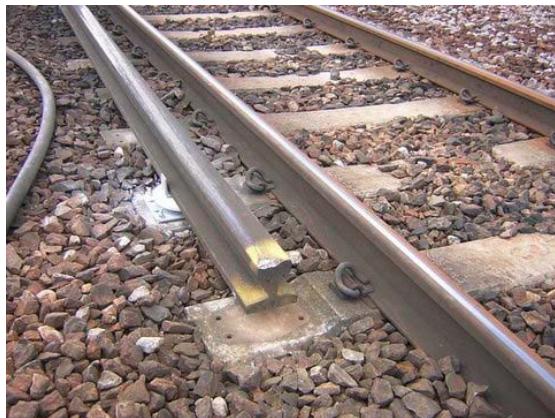
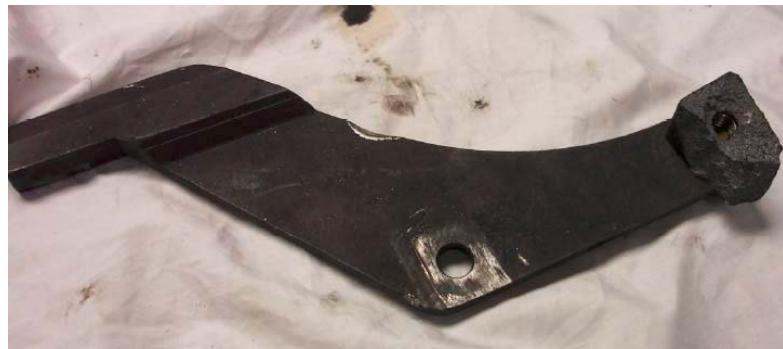
Ramp end with impact damage and bracket that hit passenger on the platform

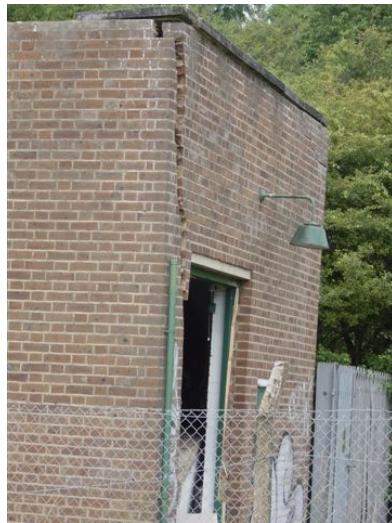
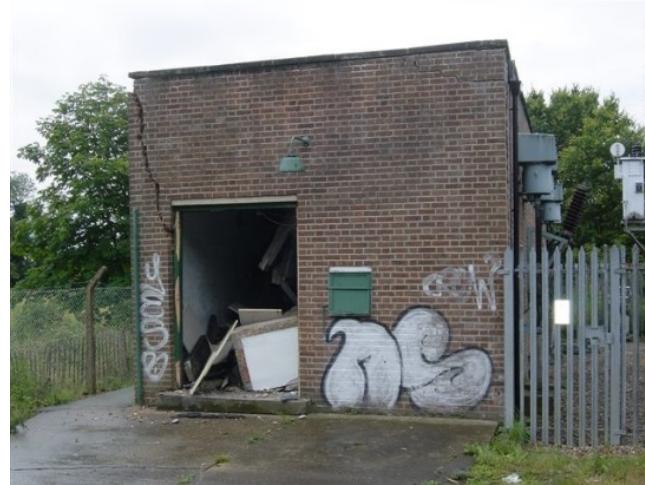
Dunton 25kV feeder station building

Dunton - 2004	Catastrophic failure of minimum oil 25kV circuit breaker	The maintenance team was not undertaking correctly maintenance tasks on the circuit breaker leading to malfunction	The circuit breaker failed explosively which led to structural failure of the building. No one was in the building at the time

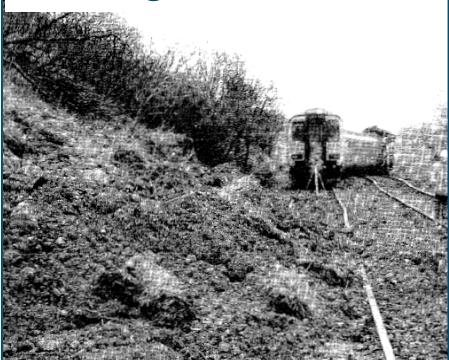
Prolonged Rainfall

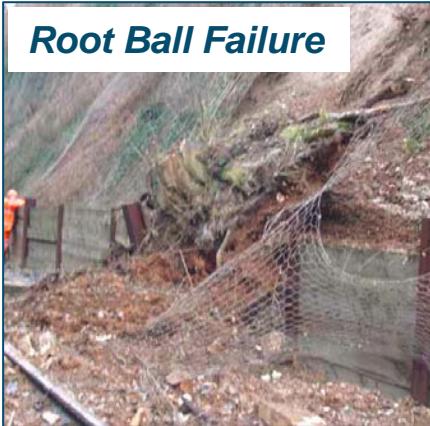
Root Ball Failure

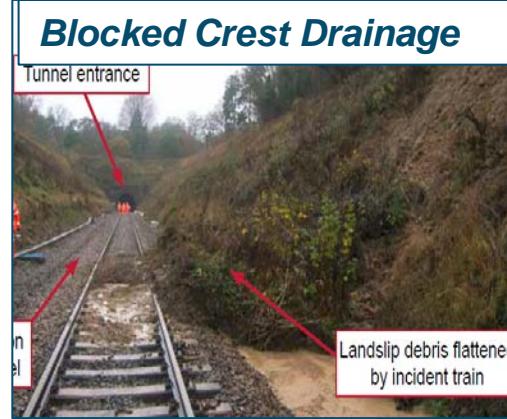
Blocked Crest Drainage

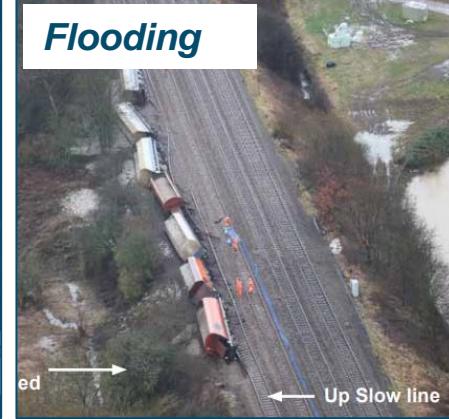
Flooding

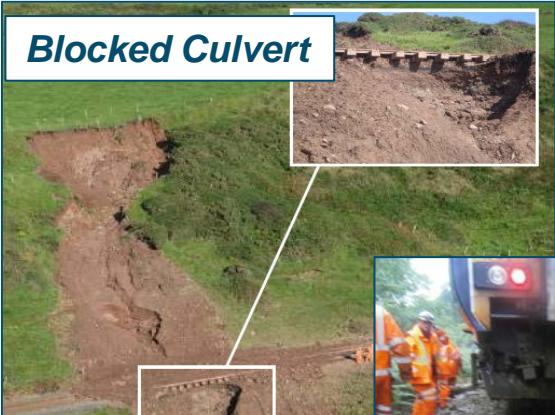
Blocked Culvert

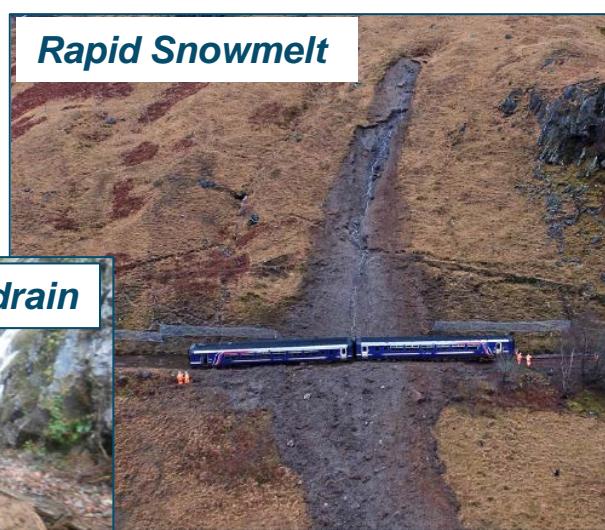
Rapid Snowmelt

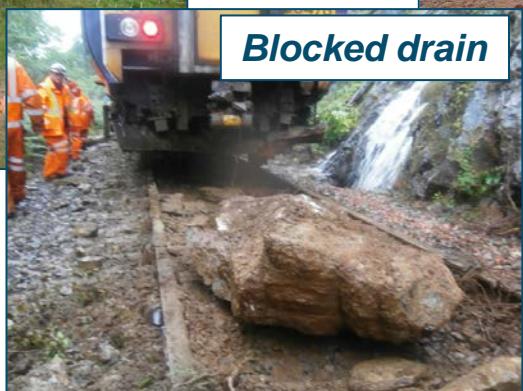
Blocked drain

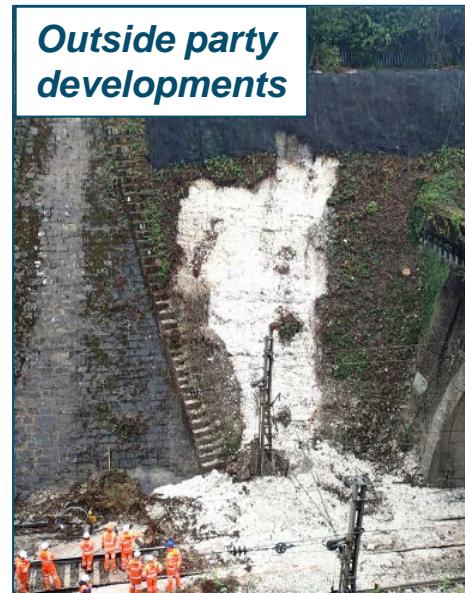
Outside party developments

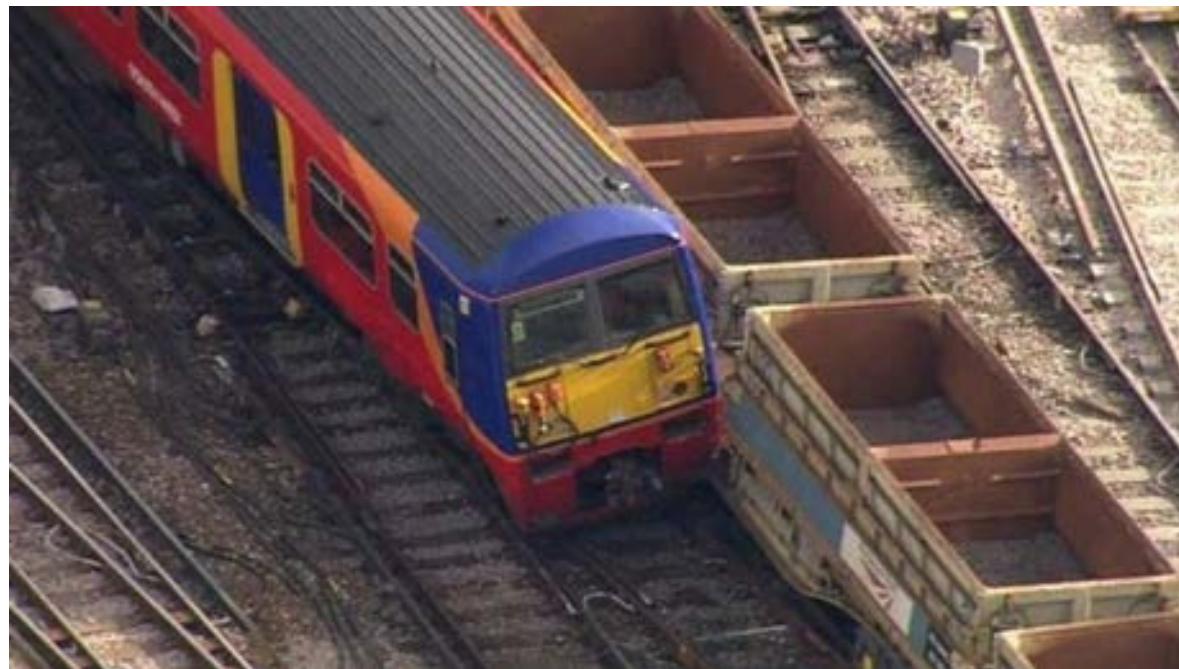
Derailment	Cause	What happened...
Waterloo - 2017	The collision was the result of an un-controlled modification to points control circuits during the testing of the Waterloo Capacity Blockade.	Investigation is still continuing!
