Safety Bulletin

Godinton Substation staff injury

Ref: SE/EP/211218/0001

Location: Godinton Substation (between Ashford and Staplehurst)

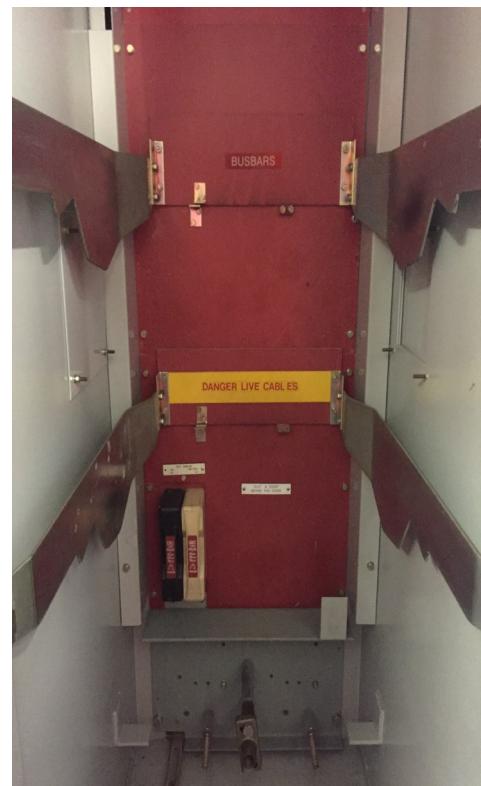
Following a burn injury at Godinton substation on Thursday 20th December, as an interim measure the following restriction shall be implemented pending the conclusion of the investigation:

- In the event of a fault in a Whipp & Bourne MM74 DC Circuit Breaker with 50V operating equipment, staff shall not enter the breaker cell to undertake any work without de-energising its incoming 750V supply.**

- South East and Wessex Routes are undertaking this interim step and recommend all Routes also do so.
- Where required to facilitate repairs, the Electrical Control Room should open the remote end of the affected section to isolate the power supply to the circuit breaker.
