IMDM OUTER**Title: Train Striking Welding Kit****Incident**

IMDM Outer. Train striking Welding kit

Issue Date: 15/02/2019

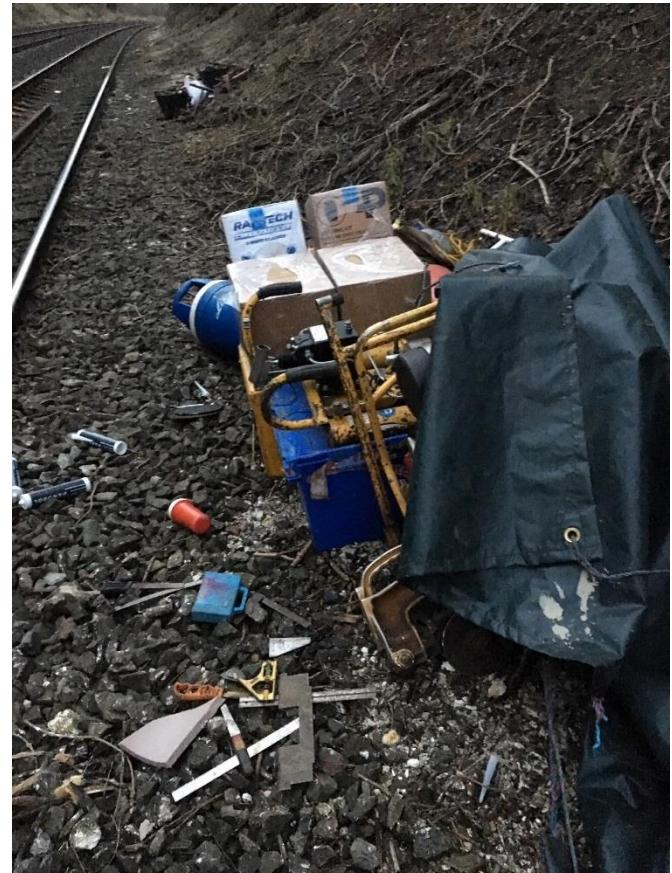
On the 12th of February 2019 at 15:42 hours, welding Kit which included a gas bottle was left trackside was struck by a train.

The location where the welding kit was stored had a slope down to the CESS, limiting adequate space from the nearest open line.

The Tarpaulin sheet covering the welder's kit had started to lift due to the updraft from passing trains. It appears that at some point during the next 8 hours the sheet had dragged the fiberglass box and the crucible down the embankment causing 1L43 Waterloo to Exeter St David's to strike the tool box and crucible.

- The importance of prior site scoping and completion of a risk assessment to identify a suitably adequate location for storage of welding kit if there are no mechanical means available to transport kit to and from site.
- If kit is to be left line side then it **MUST** be left securely; a minimum of 2 meters away from the nearest running line, 3 metres away from any other fixed equipment or portable powered plant and on level ground.
