# Near miss with a train driver at Stafford station, 2 March 2018

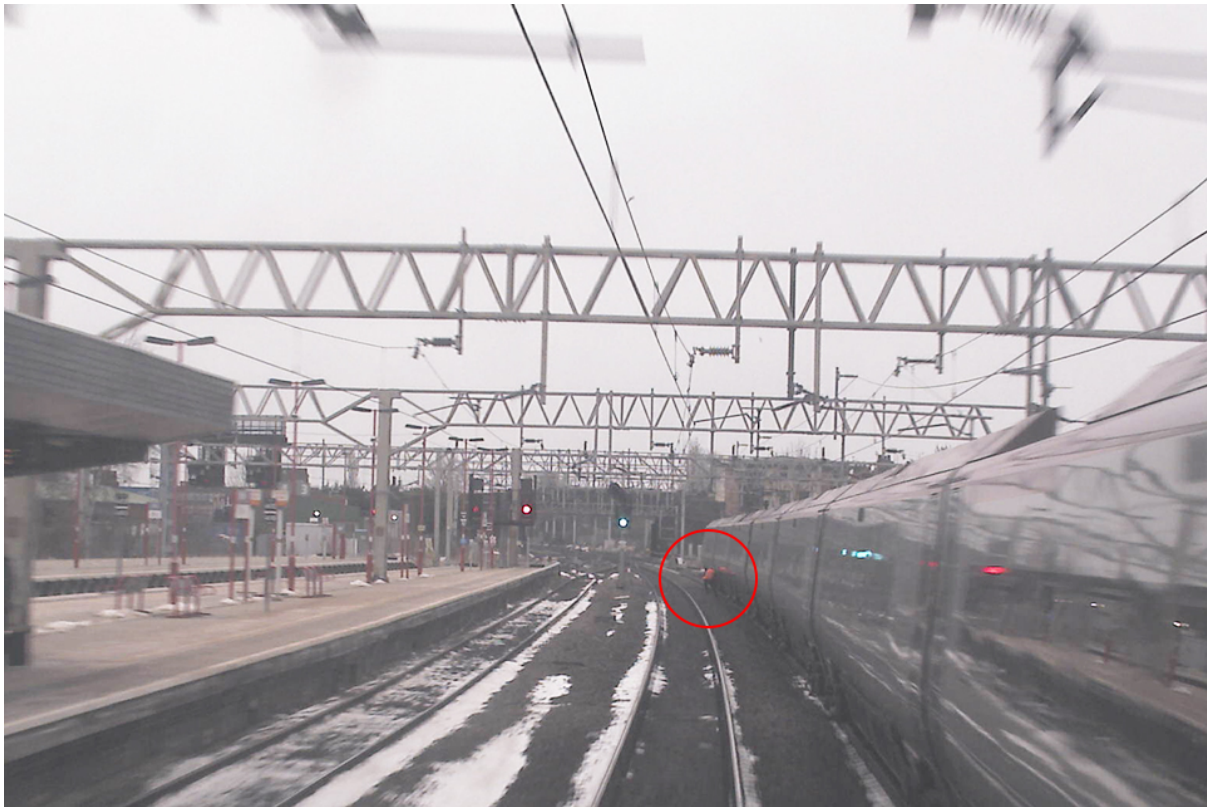
Forward facing CCTV image from the northbound (image courtesy of Virgin Trains). The driver of 1A34 is circled.

At about 14:36 hrs, the northbound train approached Stafford at about 85 mph (137 km/h) on the Down Stafford Fast line. As the driver of this train passed the front of train 1A34, he saw someone on the track towards the rear of it. The driver sounded the train's horn and applied the train's brakes. The driver of train 1A34 became aware of the approaching train and lay down alongside his train to avoid being struck. He was clear of the approaching train about three seconds before it passed him.

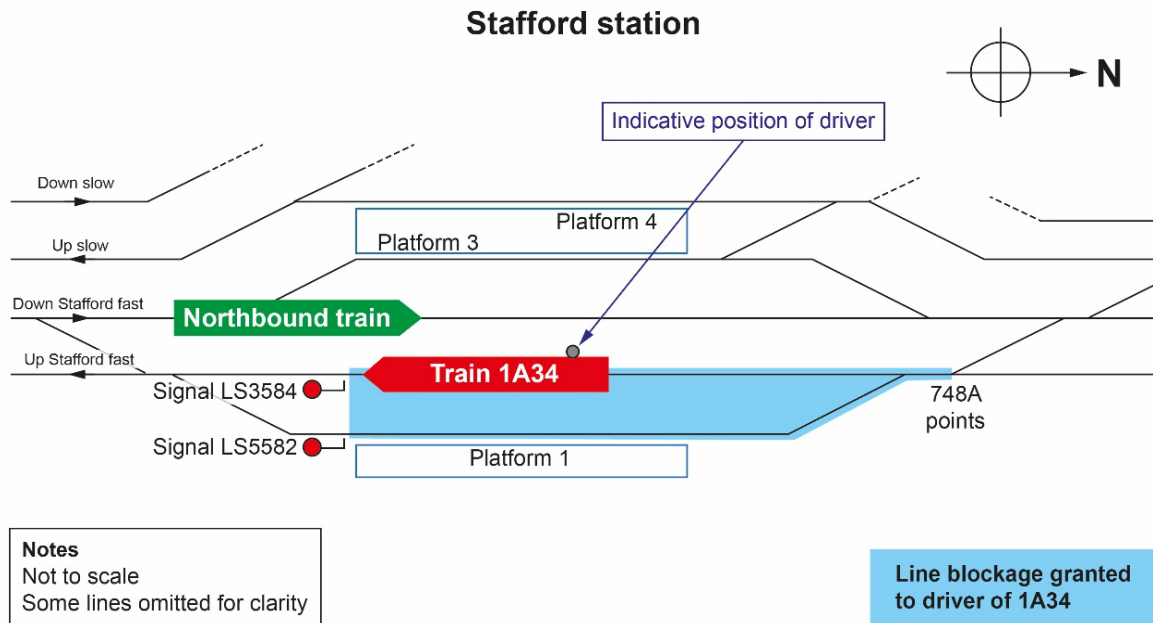
**Track diagram showing Stafford station and the position of the trains involved**

At 14:04 hrs, when train 1A34 was at a stand at signal LS3584, the driver called the signaller again. During this conversation, the driver asked the signaller to block the Down Stafford Fast line and the line through platform 1, which would stop any train movements on these lines (the driver concluded that the Up Stafford Fast was already blocked by the presence of his stationary train). The request to block the Down Stafford Fast line and the line through platform 1 was repeated back by the signaller. The driver stated that he would need these line blockages to gain access to the outside of his train, as he needed to isolate the brakes on a carriage towards the rear and then carry out a test to check that the wheels on that carriage were rotating correctly.

About five minutes later, at 14:16 hrs, the signaller called the driver back to grant the line blockages. When he arranged the line blockages with the driver, he modified the start of the line blockages to a set of points at a junction to the north of the station. The line blockages ended at signals at the southern end of the station. These arrangements blocked the Up Stafford Fast line (the line on which train 1A34 was standing) and the line through platform 1. The signaller believed this would be sufficient for what the driver needed to do, so at the end of their conversation he gave the driver an authority number for the line blockages, which the driver repeated back and recorded. However, the signaller should not have granted a line blockage for the Up Stafford Fast line as section 13 of Rule Book module TS1 'General signalling regulations' states that a line can only be blocked when it is clear of trains. This line was not clear as train 1A34 was standing on it. Also the presence of the train in this section of line meant the signalling system would not allow any other trains to be signalled into it.
