# Rail Accident Report

**Fatal accident at Trenos footpath crossing near  
Llanharan, Rhondda Cynon Taf, South Wales,  
1 June 2017**

Report 07/2018  
May 2018

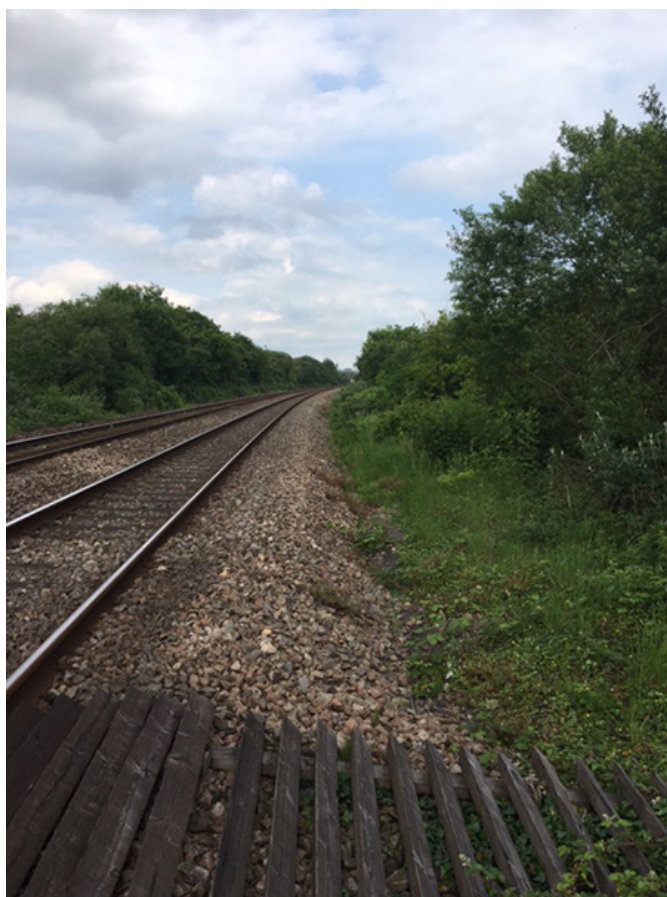
- 13 The approach from the south side is up a sloping path (figure 3 and figure 4). A pedestrian's view from this side of the railway looking towards trains approaching on the down line, the line used by the train which struck the pedestrian, is shown in figure 5.

*Figure 5: View from south side of crossing looking east towards down trains on 1 June 2018 (photograph courtesy of Network Rail)*

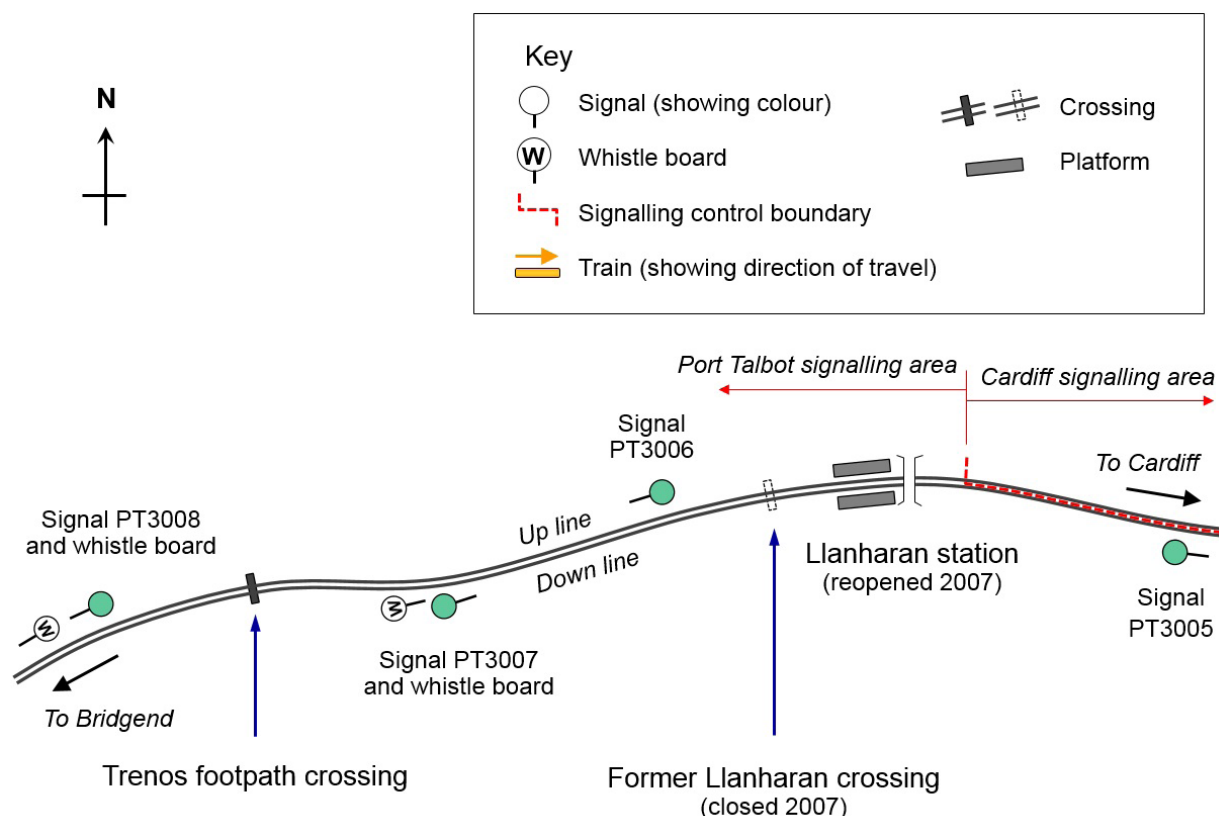
- 20 Trains travelling on the up line heading east pass a whistle board for Trenos crossing and signal PT3008 before reaching Trenos crossing (figure 7). They then continue past signal PT3006, the former Llanharan crossing and Llanharan station. Both these signals are controlled by the Port Talbot signaller. Shortly after passing Llanharan station, trains travelling on the up line enter the area controlled by the Vale of Glamorgan signaller located in Cardiff.
- 21 The maximum permitted line speed on both lines is 75 mph (121 km/h). However, the up line has a long-standing temporary speed restriction which restricts trains to a maximum speed of 50 mph (80 km/h). This provides additional protection for crossing users as the sighting of trains approaching from the west is restricted because of a curve in the track.

Figure 7: track and signalling layout diagram (not to scale). Note that the boundary between the Cardiff and Port Talbot signalling areas is staggered and signal PT3005 is within the Port Talbot signalling area.

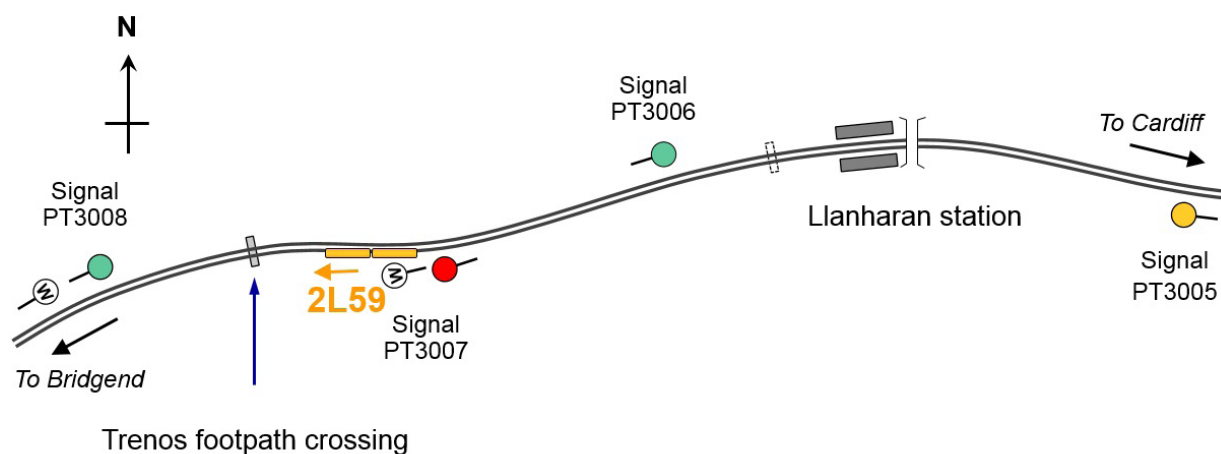
- 40 At 15:49:45 hrs (figure 13), train 2L59's data recorder indicates that the train was 250 metres (10.5 seconds) from the crossing when its driver started to repeatedly sound the train's warning horn. The driver took this action after seeing a pedestrian walking onto the crossing from the left side of the track.

Figure 13: diagram at 15:49:45 hrs
