**IMDM INNER – Earley 10th July 2019****Title: Irregular Working – Incorrect Use of a Site Warden****Incident**

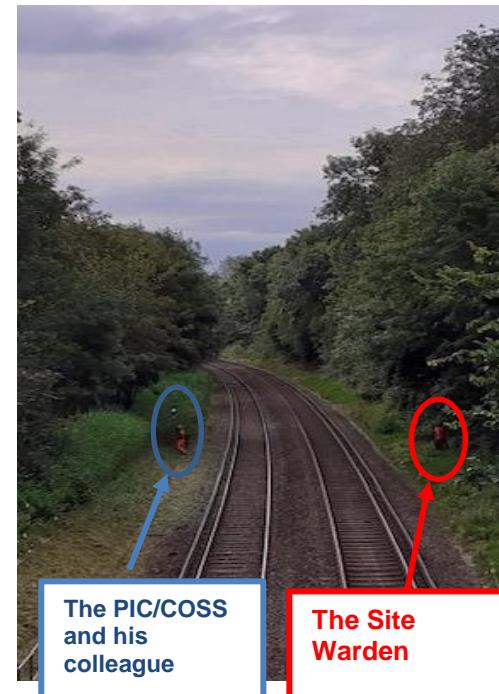
The PIC/COSS set up his 'safe system' of work and positioned the Site Warden in the Down line cess, which was 2 roads away from the rest of the team carrying out the de-vegetation work in the Up cess.

The position of the Site Warden was not in line with the Rule Book HB3 (Duties of the Lookout and Site Warden).

If the team encroached within 2 metres (6'6") of the nearest open line the Site Warden would have been unable to warn them.

It also meant that the PIC/COSS had no control or visibility over the movements of the Site Warden should he have chosen to leave his position.
