WORKS DELIVERY

Title: LTI – Asset Structure Failure

Injury: Grazed Arm and Back Injury

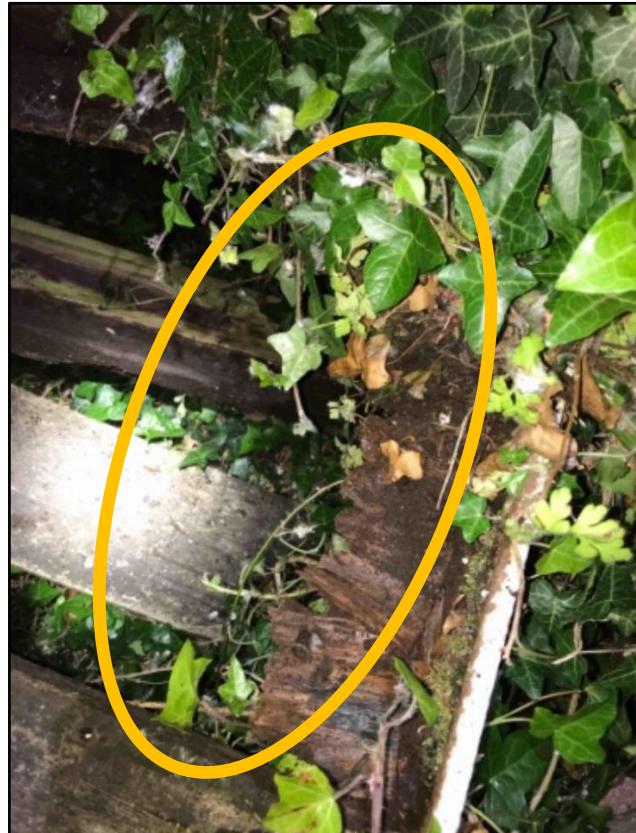
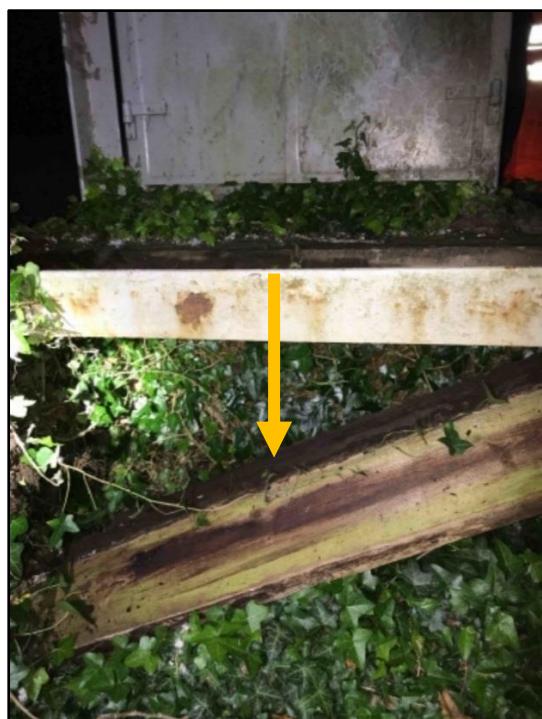
The location case is positioned on a raised platform consisting of a stilted steel frame with timber decking. Whilst working at the rear of the location case, two of the decking boards snapped approximately two inches from the end without warning, and the engineer subsequently fell approximately 1 meter through the deck and landed on the embankment ballast scraping his arm and jarring his back.

This location has not been upgraded to the current standard.

As seen by the photos, the location is surrounded by foliage therefore leading to the platform being kept in predominantly damp conditions which can lead to the rotting of timber.

The condition of the platform was not identified at the start of the works.

When working on these types of structures, additional observations are required to ascertain the condition (Take 5). If there are any concerns that the structure is in a state of dis-repair and appears unsafe, works should not proceed and the details to be reported to
