Safety Bulletin

Serious Safety Incident

Issued to: All South East Route

Date of Issue: 07/08/19

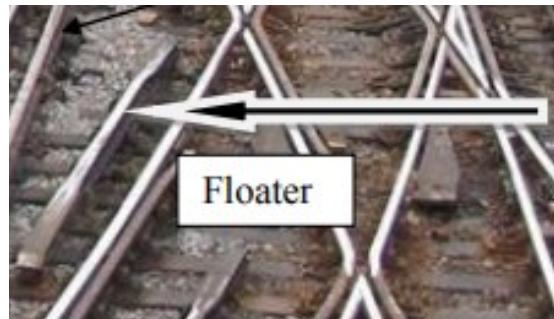
A serious safety incident occurred last night when a colleague setting up site lighting came in to contact with the live conductor rail. The live rail was a floater believed to have been isolated (example of a floater above)*.

Floater are short lengths of conductor rail that can abut or infringe an isolation and can remain live because they are fed from an adjacent live conductor rail in a different electrical section.

Never assume equipment is isolated
– always test before touch.

- Always assume that the third rail is live and test before touch
- Are you aware of live floaters in your worksites?
- Always wear the correct PPE for the task
- Are you indicating live floaters on site using devices such as self-testing con rail indicator devices?
