**IMDM INNER – Earlsfield – 5m61ch****Title: Slip, Trip and Fall while pushing an Iron Man      Injury: Ankle Sprain****Incident**

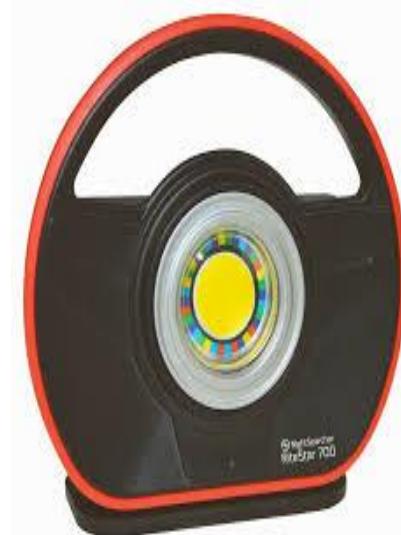
The underfoot conditions present (ballasted track) were exacerbated by the presence of tamping holes which had not been regulated (boxed in) during the tamping process.

RiteStar 700 NightSearcher magnetic light and a stock photo of a Tamper

- **Is the site lighting being used suitable for the work being undertaken? Head torches are useful, but consider other lighting, such as the RiteStar 700 NightSearcher light.**
- **Be aware of your underfoot conditions and pay particular attention to uneven ballast**
- **Think P.R.I.C.E.**
