## TRANSFERRABLE LESSONS FROM SERIOUS OPERATIONAL INCIDENTS / INVESTIGATIONS

Issue No: NR/OPS/039 Date Issued: 10/10/18

#### Line blockage irregularity Tram Inn Signal Box

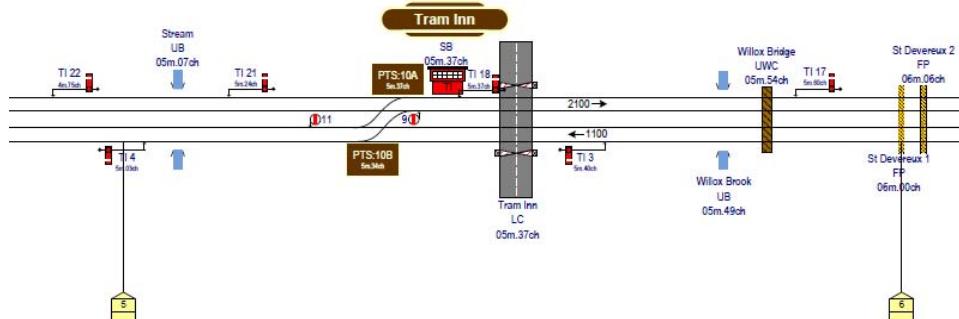
On 03/10/18 at 09:33 a line blockage was granted from Tram Inn SB to Abergavenny SB to protect an IWA between Pontrilas SB and Abergavenny SB. After the line blockage was granted the IWA reported that a Rail Head Treatment Train 3S59 passed through their line blockage at 09:44, when the train passed the IWA was in a position of safety.

Tram Inn would normally protect work between Tram inn and Abergavenny when Pontrilas SB (intermediate SB) is closed. The Line blockage/GZAC was planned with this in mind however, Pontrilas SB was open at the time and therefore should have protected the line blockage given that the work was in that area of signalling control.

Upon agreeing the line blockage arrangements, the trainee signaller was not familiar with the location of work given by the IWA (Trilley Mill - located between Pontrilas and Abergavenny). However, the line blockage signals were clearly identified between Tram Inn SB (TI 17 signal) and Abergavenny SB (AY 51 signal) so at this point the signaller/trainee signaller should have identified that the line blockage extended through Pontrilas SB area of control. The IWA was not aware Pontrilas SB was open. Both trainee and mentor signallers were aware Pontrilas SB was open. Pontrilas SB however was not made aware of the line blockage request.

Regardless, upon receiving train out of section from Pontrilas SB at 09:31, the line blockage was granted from Tram Inn SB to Abergavenny at 09:33 with RHTT 3S59 in section between Pontrilas SB and Abergavenny SB which then entered the line blockage at 09:44.

- Trainee signallers should be closely monitored at all times to ensure the correct application of rules and regulations are followed.
- Operational form NR3180 should be cross examined by the mentor signaller before line blockages are granted. Had this occurred the mentor signaller would have realised that the location extended beyond Pontrilas SB and either told the IWA to take the line blockage from Pontrilas SB or taken additional precautions.
- Signallers should be checking what planned line blockages are booked on commencement of their shift for knowledge and also workload planning and the Irregular opening/closing times of Pontrilas SB led to the line blockage being planned incorrectly from Tram Inn.

- Signallers should check that trainee signallers have a clear understanding of any booked line blockages. Signallers should also check with the trainee at regular points during the line blockage request call.
- Countersigning of NR3180 by mentor signaller to ensure all details are correct should be considered.
