**Transferable Lessons from Serious Operational Incidents / Investigations**

| <b>Issue No:</b> | <b>NR/OPS/041 (V2)</b> | <b>Date Issued:</b> | <b>21/10/2018</b> |

**Train speeding through Emergency Speed Restriction at West Byfleet**

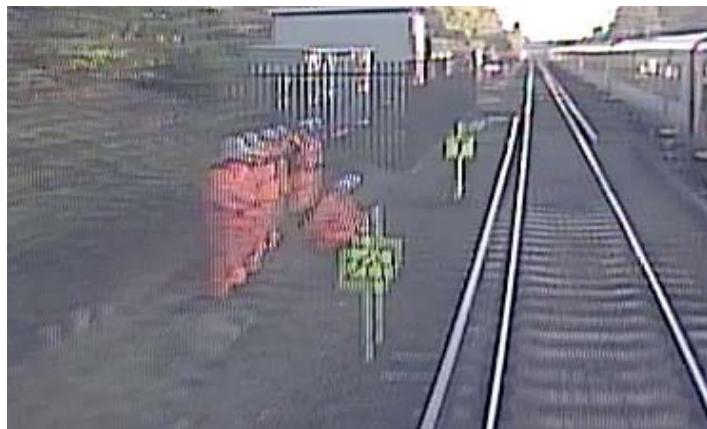
On Friday 19<sup>th</sup> October a broken rail was discovered on the Up Slow line at West Byfleet which resulted in the line being blocked. The broken rail was clamped and a 20mph Emergency Speed Restriction was imposed, following erection of both the termination and commencement boards, the Pway staff found they were unable to position the first portable AWS magnet due to rails being positioned in the four foot, no other equipment had been positioned (warning board and indicator)

The Signaller operating panel 2 at Woking Area Signalling Centre was advised of the above information and the requirement to caution trains at 20mph, despite repeat backs being used the Signaller misunderstood this information and believed that all speed boards were in place and that the only issue was a missing portable AWS magnet. The Signaller operating panel 2 advised their colleague operating panel 1, who then advised the first passenger train 2B24 that an Emergency Speed Restriction had been imposed and that the only issue was a missing portable AWS magnet.

Staff on site reported to the Signaller operating panel 2 that 2B24 had passed over the defect around 50/60mph, this was due to the driver not being provided with the correct information about what lineside equipment had been erected for the Emergency Speed Restriction.

- Always ensure that there is a clear understanding about what lineside equipment is in place Rule Book Module SP "Speeds" mandates that if it is necessary to allow trains to pass over the ESR before the equipment is in place, you must stop each train which will travel over the ESR and tell the driver the location where the ESR begins and ends and the speed limit imposed.
