## NATIONAL OPERATING PROCEDURES

Issue: 1 NR/OPS/ 83 Date: 25/02/2020

### CCTV Level Crossing irregularity—Alsager CCTV

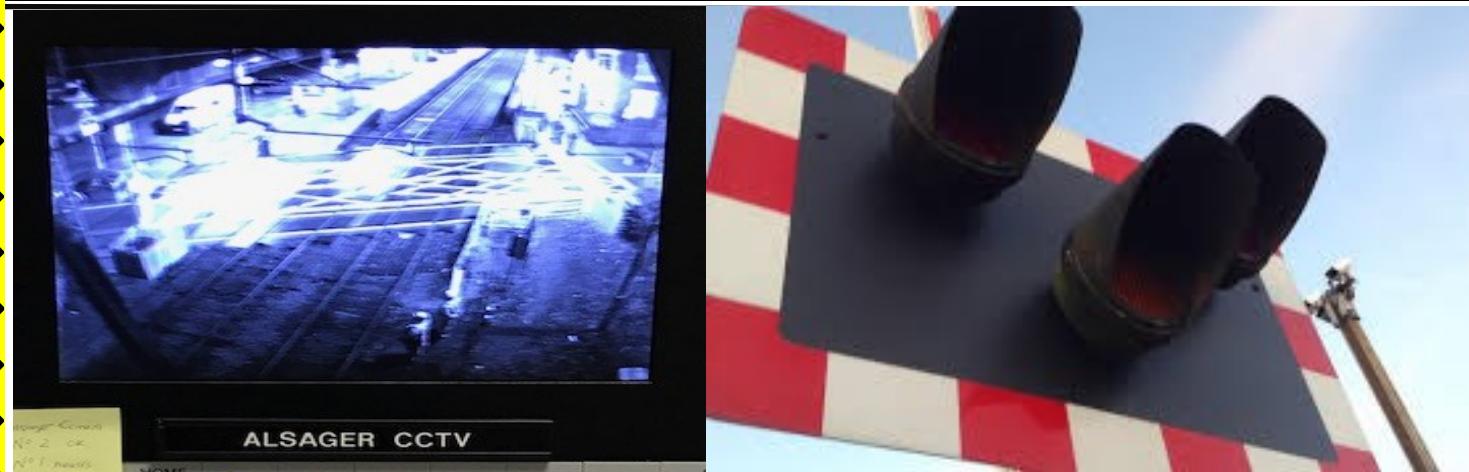
On Friday 21<sup>st</sup> November S&T were responded to a fault at Alsager CCTV Level Crossing. Upon arrival, they found two members of public trapped inside the crossing. The S&T staff ensured the members of public remained in a safe position as a train passed them.

It was established that both cameras covering the crossing had been reported as defective due to the quality of the CCTV picture but the signaller did not identify the members of public trapped within the crossing prior to pressing crossing clear.

1. Observe the crossing to ensure that it's safe to begin the lowering sequence (for auto lowering skip to step 3)
2. When safe to do so, press **LOWER** to begin the lowering sequence. Observe the lowering sequence where instructed locally.
3. When the lowering sequence is complete, **CHECK** the crossing is clear using the figure of 8 scanning technique.
4. If in doubt, **CHECK AGAIN**, ask another person to assist or raise the barriers and return to step 1.
5. If the crossing is **OBSTRUCTED**, you must **RAISE** the barriers and return to step 1.
6. If you are unsure that the crossing is clear (as in the case above), you must treat the crossing as defective, call for an attendant and apply the appropriate rules in TS9 6.5.2.
7. If the crossing is **CLEAR** press **CROSSING CLEAR**.
8. **Report** and **Close Call** any poor quality CCTV pictures.
