Safety Bulletin

An Operating Irregularity has taken place

Issued to: Southern Region
Reference: Operational Close Call
Date of Issue 17th July 2020
Location: Durnsford Road at 6m 28ch - Line of Route BML 1, (Wessex Route)
Contact: Wessex Access Planning and Delivery Team

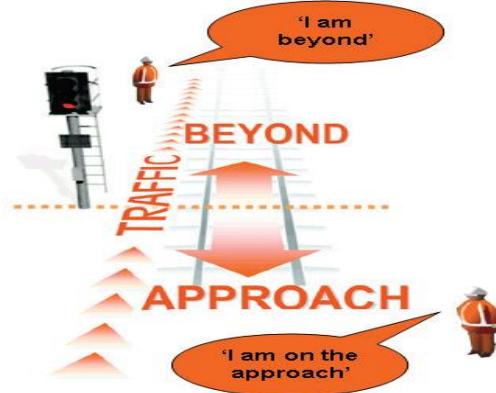
The Duty ODM arrived to undertake Possession Assurance check on Detonator Protection at Durnsford Road, when it became apparent that the protection on the Down Main Fast and Up Main Slow had been placed on the incorrect side of the points, countryside vice London side. The Down Main Fast protection had been placed Beyond W705pts vice on the Approach. The Up Main Slow protection had been placed on the Approach to W704Pts vice Beyond.

The ODM took over the PSS duties and got permission to place the protection on the Down Main Fast and Up Main Slow correctly.

- Ensuring that SWP's and other relevant information and paperwork are supplied on time and in line with 019 Standard
- How do you assure yourself that your briefing is fully understood by the other party if it can't take place face to face?
- Take 5 and always question/seek confirmation if something is unclear.
