# Safety Alert

## Electrical Safety Incident

Date of Issue: 15/07/2020

Location: Slade Green Depot, Kent

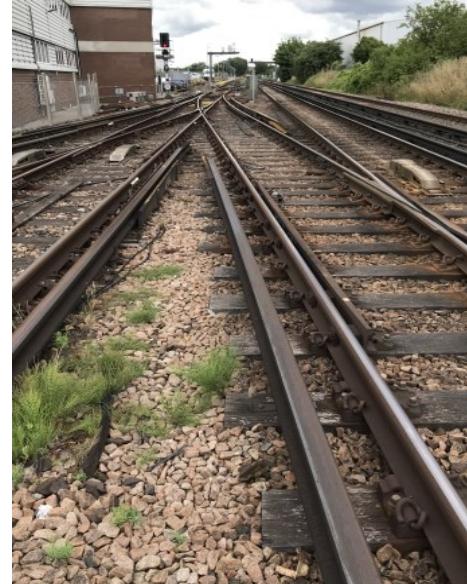
During work to change rail within a sidings possession, on 12 July, a member of staff suffered burns to his ankle when the handle on his ironman came into contact with the conductor rail, causing an arc flash. The Seaward Live Line Tester used to test the conductor rail didn't operate correctly and damage to the probe, was subsequently identified. A national safety bulletin has been issued on this.

It has also been identified that the rail change had been planned and agreed at a local level between the delivery unit and worksite owner. This had not been published in the possession pack, and therefore isolation arrangements did not take into account the additional activities required to undertake this work, which included the use of ironmen.

- All additional work added to an existing worksite already published in the Possession Planning System (PPS) must be requested and approved via the relevant access change process, and PPS updated accordingly. Similarly any fundamental change in the type of work being undertaken must follow the same process to ensure the planned isolation provides the right level of protection.
- The presence of any Live Floaters that cannot be isolated within or adjacent to a worksite must be documented in the PICOP and ES packs and briefed prior to the start of any work.
