## NATIONAL OPERATING PROCEDURES

### TRANSFERRABLE LESSONS FROM SERIOUS OPERATIONAL INCIDENTS / INVESTIGATIONS

## Multiple Points Run-Through & Near Miss —Wembley

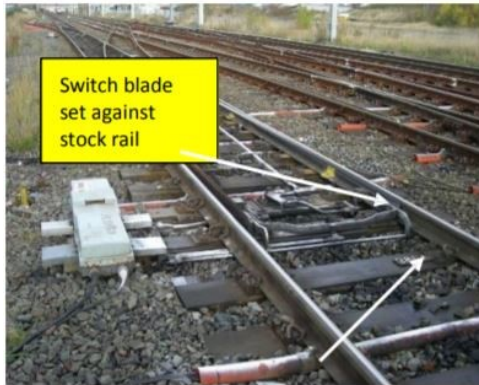
NORMAL POSITION (identified by the point identification plate closest to the CLOSED end)

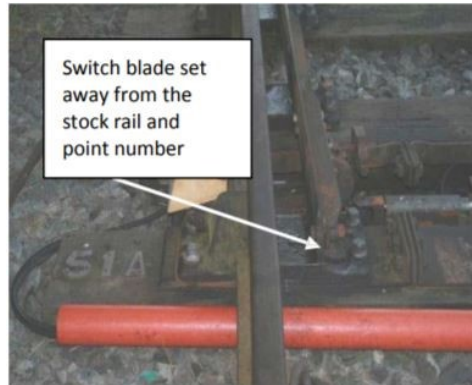
REVERSE POSITION (identified by the point identification plate closest to the OPEN end)
