Safety Bulletin

A Workforce Accident has taken place

Reference: Compound Fracture

Location: Brookwood, Woking. Wessex Inner

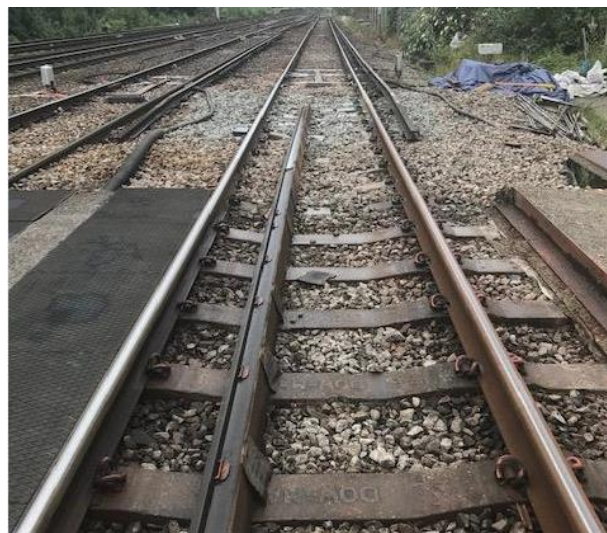
On Wednesday the 8th of July 2020 at approximately 02:00, a member of staff sustained a compound fracture when a scrap rail weighing approx. one ton, rolled over and crushed his right foot.

Having cut and lifted the affected section of rail from the track and onto the 4foot, the team were installing the new rail when the scrap rail which measured approx. 54 (16.5m) that had been left in the 4foot, rolled on top of the IP's foot. The team lifted the rail manually and moved the IP away from the track, where First Aid was administered.

It is currently not clear what caused the scrap to roll. Later inspection revealed patches of ballast on sleepers throughout the site of work and a kink in the old rail. These two conditions may have contributed to the rail laying unevenly in the four-foot making it unstable and causing it to fall when a minimal force was applied unwittingly by a member of the team.

- *The importance of site preparation/scoping prior to work commencing*
- *Ensure there is clear on-site communications and control when team handling is taking place*
- *Competency and experience within the team for the task being undertaken*
- *Are your boots in a good condition and do they have metatarsal protectors?*
