What happened?

At St Denys Station, work was being undertaken to drill into the station canopy steelwork as part of canopy replacement works.

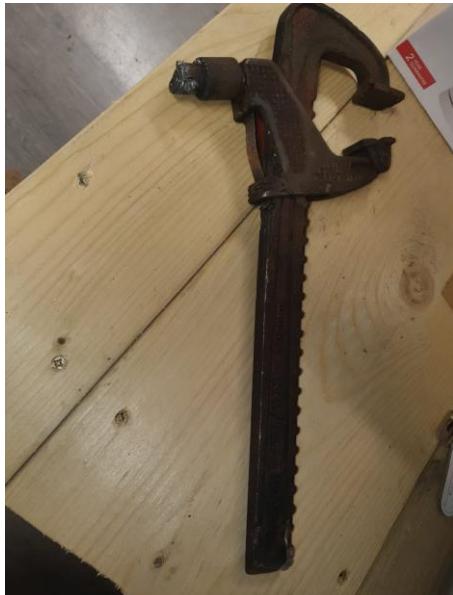
Clamp being used

Access to the canopy was via a GRP mobile scaffold tower. The drilling template was being held onto the steelwork by 2 Rack Clamps. The drilling was being completed using a mag-drill. The mag-drill snagged during the drilling causing the drill to spin round and impact the handle of the clamp. This caused the clamp to come off the canopy steelwork and be propelled onto the track below. The clamp landed in contact with the live 3rd rail and the running rail just beyond a 12 metre run of conductor rail shrouds. No one was injured.

- ✓ When working at height, ensure that all items of equipment in use are tethered to the individual or to the structure, whichever is appropriate.
- ✓ Ensure that an appropriate exclusion zone is in place below work at height.
- ✓ 'Mag-drills' are known to snag and spin, has this been accounted for in the safe system of work. Is it the safest tool for the job?
- ✓ Is the 3rd rail sufficiently protected?
- ✓ If unsure of how to proceed, stop, think and consult your supervisor or SHE Advisor for guidance.

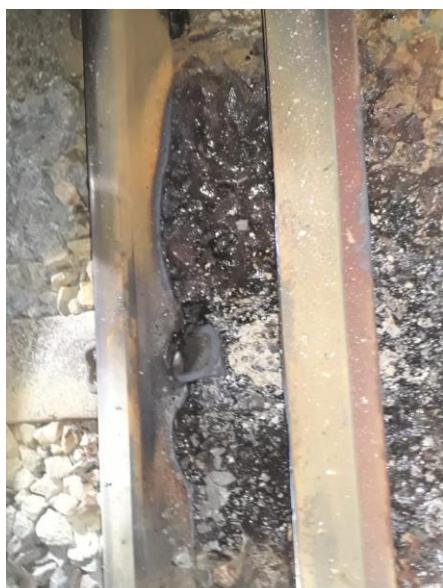
Damage to the running rail

- The short circuit caused damage to the 3rd rail and the running rail which required replacement of a section of running rail and repair to the 3rd rail.
- There was potential for injury to personnel if they had been hit by the clamp or been near to the rails at the point of impact.
- There was disruption to the rail service while repairs were undertaken.
