# Safety Bulletin

An Operating Irregularity has taken place

**Date of Issue** 13<sup>th</sup> April 2021

**Location:** Salisbury Station Area - Line of Route BAE1, (Wessex Route)

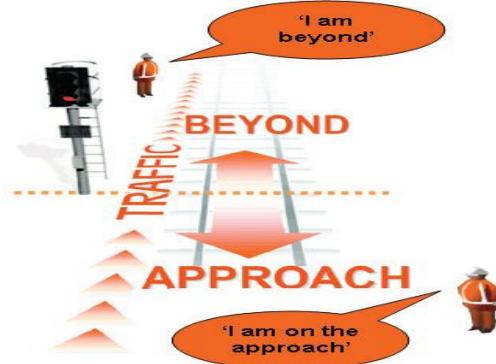
At 00:13hrs (Sunday), the Duty Outer ODM was informed by the Wessex Integrated Control Centre (WICC) that the Signaller at Salisbury noticed that the Possession Limit Board (PLB) and Detonator protection on the Up Main Line at Salisbury station had been placed the wrong side of the protecting signal SY46, beyond SY46 vice on the approach.

- Being focused and paying attention to details and referring to all associated paperwork in order to manage tasks safely and effectively.
- Always Take 5 and seek confirmation if something is unclear, never assume.
- If PLB and detonator protection has been placed incorrectly, ensure the correct procedure is followed before moving it to the correct location – specifically that permission is given by the signaller and PICOP and the line is protected.
- When planning substandard worksite/possession, you must ensure suitable distance for placing of the PLB and detonator protection.
