# Team talk

& Safety brief

Period 2

Our periodic video and discussion pack for everyone in Wessex

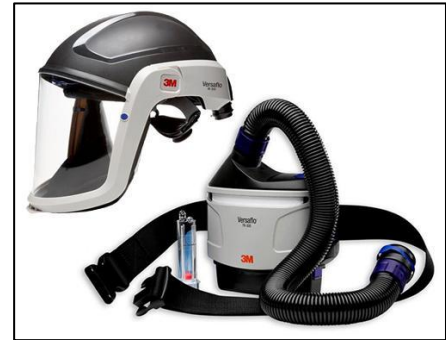
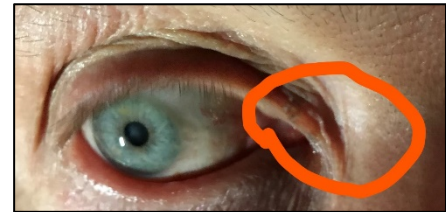
On 06/05/2021 at approx. 0230hrs a member of the welding team was flame cutting as part of a defect removal at Hershams, when a molten spark struck and caused a minor burn to his eye lid.

1. The Task Risk Control sheet (TRCS) mandates that for this activity a positive air fed respiratory protective equipment (RPE) should be worn. This equipment provides protection for both lungs and eyes and is combined into one headtop.
2. The individual experienced problems with the RPE at the start of his shift but made a decision to carry on with the job without the mandatory RPE instead of sourcing a satisfactory replacement.
3. The PiC for the job did not delegate the task risks associated with the welding activity over to the welding team.

- *Always wear the correct PPE as specified in the Task Risk Control sheets.*
- *As per the slide in Period 12 HSE Cascade, the PiC may choose to delegate task risks to a Task Risk Controller as the PiC will not always have the technical understanding of the activity.*
- *If any of your PPE/RPE/equipment is not fit for purpose, make the PiC/COSS aware and seek an alternative. Do not carry on regardless.*

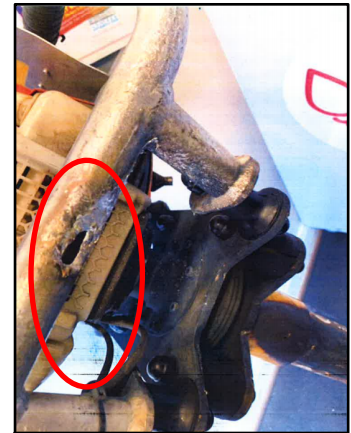
Following the completion of the work, one of the team was in the process of laying a Robel handheld tamper down, when it slipped from his grasp and came into contact with, firstly, one of the conductor rail shields, before bouncing onto the live conductor rail and then the running rail causing an arcing between the two rails.

Fortunately no injury was suffered by any member of the team and only surface damage occurred to both rails as a result of the incident.

The Robel Hand Tamper with damage circled

- *Consideration should be given to the type of activity/task and whether it can be done safely with the conductor rail live or whether an isolation is needed. If the task is undertaken whilst the conductor rail is live, how many conductor rail shields would you consider sufficient?*
- *Is the worksite that you're working in sufficiently illuminated for the tasks being undertaken? Can the conductor rail be clearly seen by everyone within the team?*
- *Has the PiC/COSS brief clearly highlighted the third rail to all members of the team and is there a continued vigilance and reminder of its risk throughout the task?*
- *Are you wearing the 'right' gloves to maintain a secure grip of the tools that you are using? Are they clean, free from grease and in good condition?*

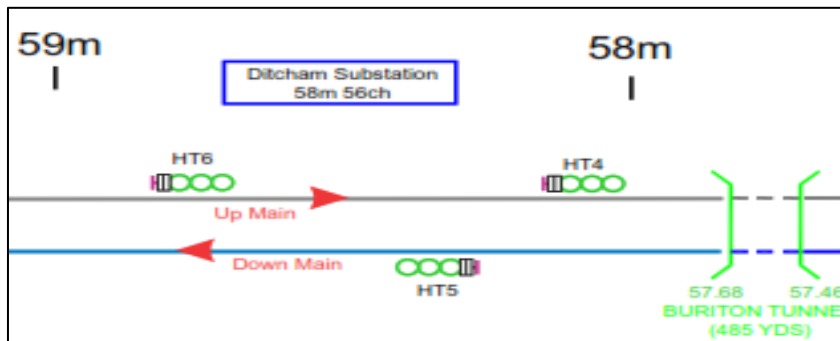
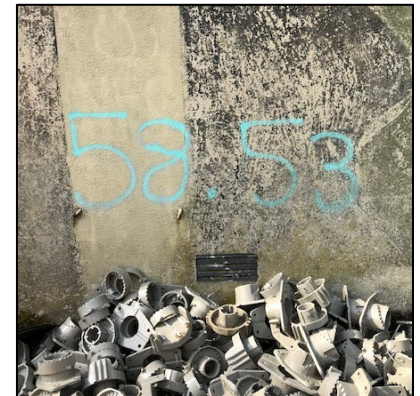
On Friday 12/06/2020 at approx. 0042hrs, a member of staff tasked with application of short circuit straps (SCS) as part of a T3 possession under a B2 current isolation on the Up/Down Main Line (WPH1) at Ditcham Substation, received an electric shock from the conductor rail that was energised at 750V d.c. This resulted in the individual receiving severe burns to his hands, face and legs and a significant period of recovery before he was able to return back to work.

1. The SCS were applied to an energised section of the conductor rail and the process for safely applying the straps was not followed.
2. Electrically insulated rubber gauntlets specified for this process were not worn.
3. The identification of the correct strapping locations was hindered by poor mobile signal on site resulting in inaccuracies in the GPS location. There was also conflicting (unofficial) location information painted on the substation wall (photo below).
4. The SWP provided clear location information that could have been used by the individual on the night, but they chose to rely on local knowledge, unofficial milage signs and GPS apps, in a known area of poor GPS app signal.
5. There was no historical evidence that on site safety tours or checks were carried out to assure the strapping process was being carried out correctly in line with the competency regime.

- Knowing your location - check the details in your SWP and isolation document. Refer to the information on the access gate and use location app if available. Confirm they all indicate the same information/mileage. If in any doubt check with the ES.

- Always follow the correct SCS application process (you must be competent to do so) – to not do so will be a Life Saving Rule breach and will cause you severe injuries if you are in the wrong place.
