Home Safe

Network Rail

The Southern Region's Weekly Safety Update 9 March

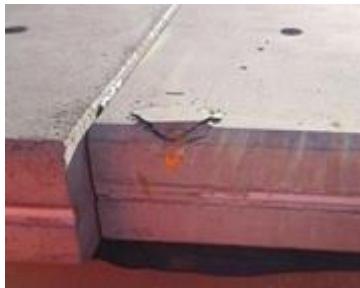
During works at Cambridge North Station, a civils telehandler struck some newly installed platform slabs from the rear of the platform, forcing them to move into the railway envelope. The planned works included tamping the track to achieve realignment; however, there was an issue with the tamper and the plan was changed during the shift in order to continue works.

The change of works and damaged slab were not identified until 24 hours later as part of a safe start walkout to review the weekend works. The site team immediately reported the issues, before rectifying the situation under a new plan and line block. *Click on the image for full bulletin.*

- How are changes to methods of work managed on your site?
- Are inspections carried out before work commences and after work has finished?

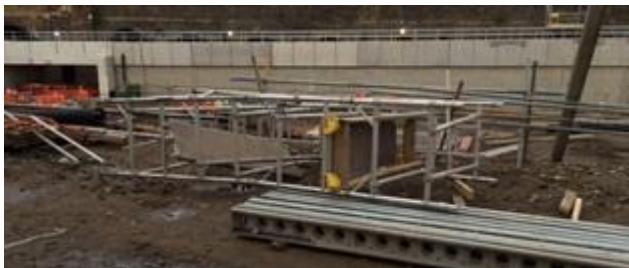
Mobile scaffold tower blown over

A Thameslink operative sustained a minor injury after a mobile aluminium scaffold tower overturned, catching his safety helmet and subsequently cutting his ear.

The tower was not in use at the time of the incident but had been left in the area as a temporary storage point. The operative was retrieving materials close by when a gust of wind blew the tower

over. The tower was situated on reasonably flat ground; however, although the outriggers were fitted, they had not been deployed.

Plant, equipment and materials storage should be considered during the planning stages. Always factor in weather conditions when risk assessing the work.
