Team talk

& Safety brief

Period 12

Accidents and Operational Close Calls Period 12

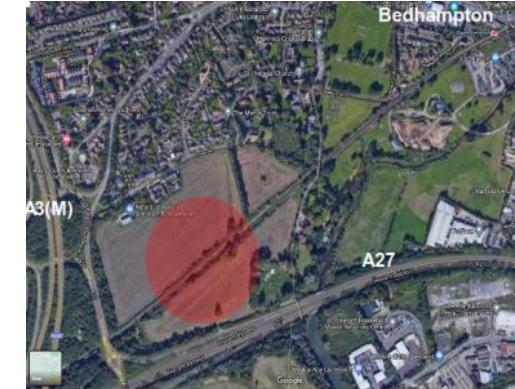
Near Miss at Bedhampton – Works Delivery (P11)

At approx. 1110hrs, the 10:00 1S16 train from Brighton to Portsmouth Harbour approached on the Down Line (line speed of 85mph). A horn warning and flag was used by the Distant Lookout to inform the team a train was approaching, however the Site Lookout failed to notice the warning. The Person in Charge (PiC) did notice the warning and the team were in a position of safety (POS) for approx. 7 to 8 seconds before the train passed their location.

The initial investigation established that the Site Lookout was tired following his journey to site. It transpired that the lookout had to make a 3 hour journey each way.

- *How are suppliers of contract or contingent labour monitoring fatigue in the staff they supply?*
- *How do you confirm the use of locally sourced contractors or the provision of accommodation to minimise fatigue risk?*
- *As a PiC/COSS are you asking the workgroup if they have any fatigue issues when giving your brief and are you scanning sentinel cards for information prior to going on or near the line?*
- *Do your teams PiC's/COSS' test their SSOW at the site of work to ensure it is suitable, prior to starting work?*
