Safety Bulletin

Tyre blow out on Motorway

Ref: WXB 15/01

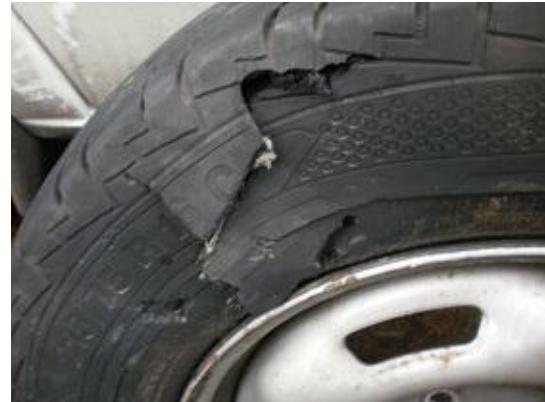
Whilst travelling on the motorway at c.60mph, the rear driver's side tyre blew out causing the vehicle to veer towards the central reservation. The vehicle collided with the Armco. This collision caused the vehicle to then veer towards the hard shoulder where the driver managed to bring the vehicle to a halt.

- The tyre had a screw in the tread which had penetrated the casing
- The tyre wall looks to have been struck by an object which eventually led to its failure and blow out

- Are you checking the side wall of tyres for damage and bulging? be aware that the tyre side wall is its weakest point
- How do you ensure that you have carried out a pre use vehicle check before driving the vehicle?
- What might prevent you from spotting similar defects and how might you overcome this?
