Network Rail Eastleigh Delivery Unit Staff Incident -

Sunday, 20th December 2015

Task: Loading sleepers onto a flat bed via the tail lift

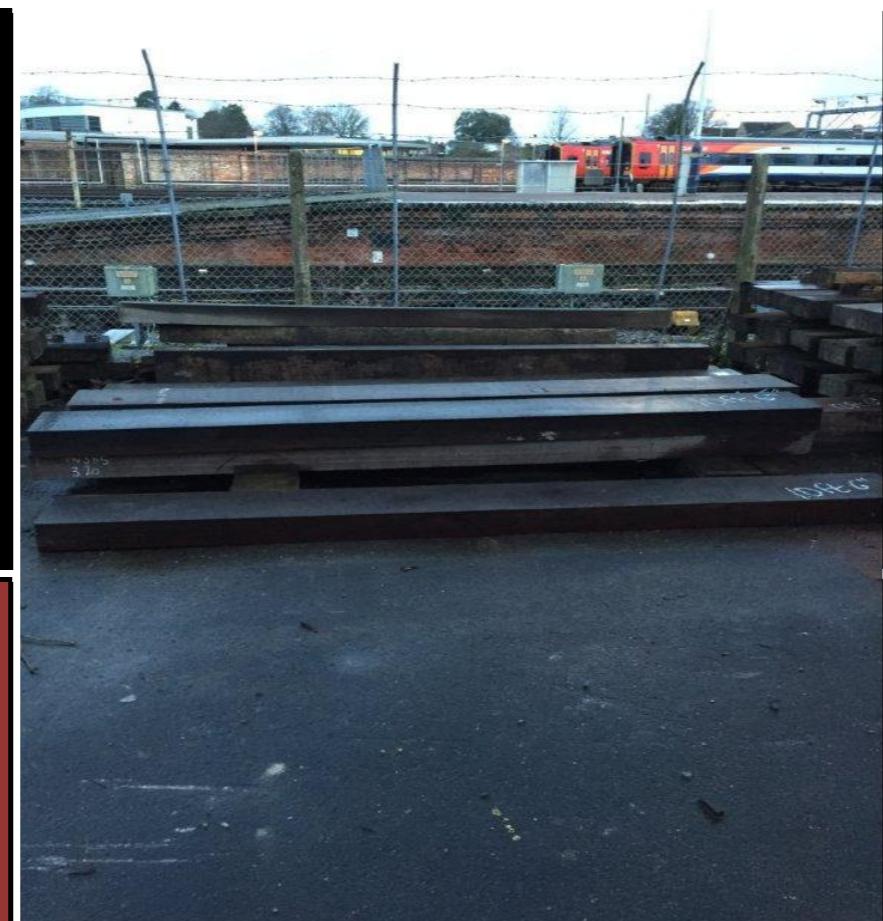
Positioning of flat bed in relation to stock pile.

This was the second load that the gang had loaded that night, as a load had already been taken to site and installed.

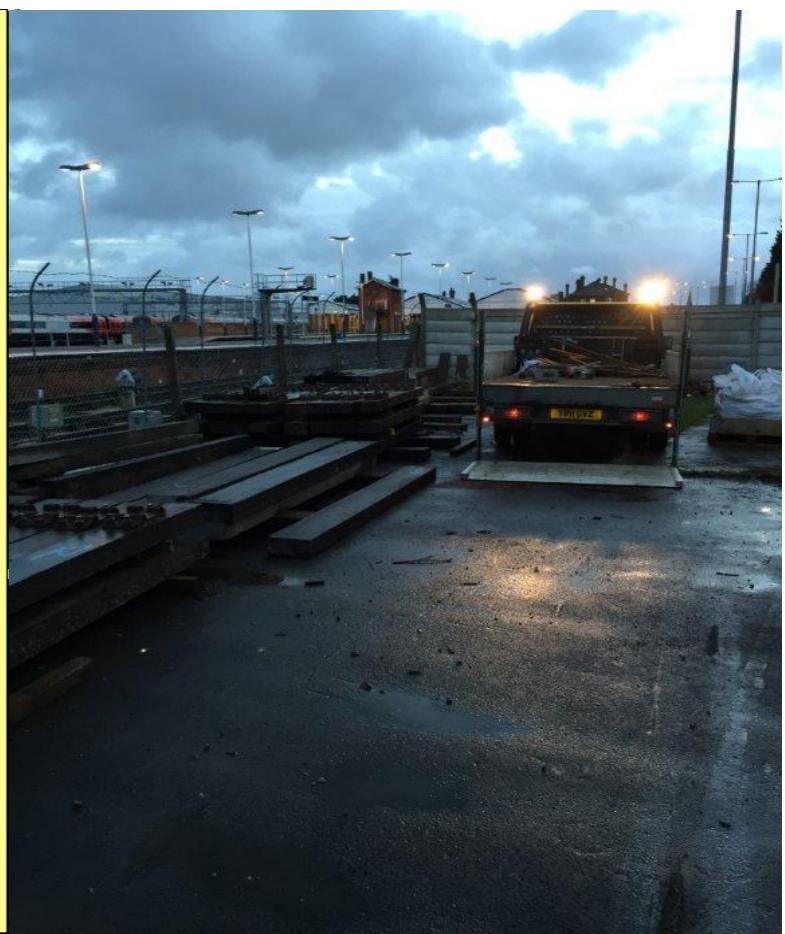
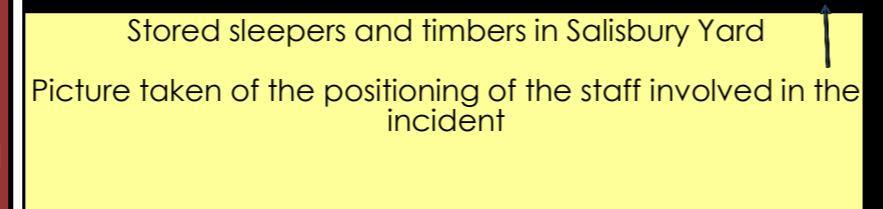
Stored sleepers and timbers in Salisbury Yard
