# ALERT-OSB-97

## Van Vaults / Tool Stores

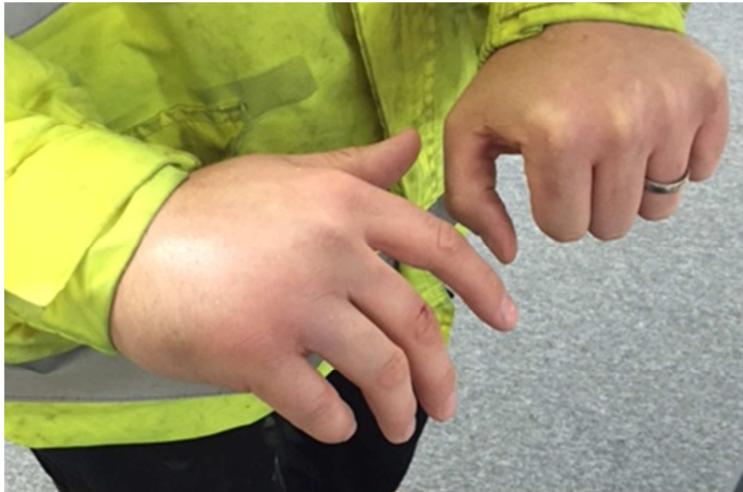
- One of our carpenters was injured as a result of a van tool vault lid falling on to his hand when he was organising his tools.
- This caused a fracture to his hand, requiring his hand now to be in plaster for 6 weeks.
- This is not the first injury involving van/tool vaults!

**The Van Vault piston arm was missing in the middle and the stay arm was broken.**

- Check all van vaults / tool stores on your vans / sites and make sure they are in good working order.
- If any parts are missing or broken, stop using it until either repaired or replaced.
- Please make sure when carrying out your weekly inspections, you are checking all work equipment including van vaults / tool stores.

- Are work equipment, and need to be inspected regularly.
- If defective they should be repaired / replaced when necessary.
- Hydraulic rams are the preferred mechanism for the lids, as they prevent uncontrolled dropping of the lid.
