Infrastructure Projects Southern

Home Safe

The Southern Region's Weekly Safety Update

27 April 2016

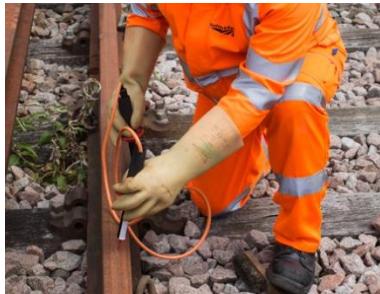
Latchmere Curve: what happens when you don't test before touch.

There continues to be a number of Controllers of Site Safety (COSS) who do not test the conductor rail to check that it is isolated.

'Test Before Touch' is one of our Life Savings Rules and requires the COSS to test the conductor rail at the location they are working to prove it is isolated. This check needs to be performed every time they start work within a worksite and every time they move location within the worksite, irrespective of being in possession of a Conductor Rail Permit.

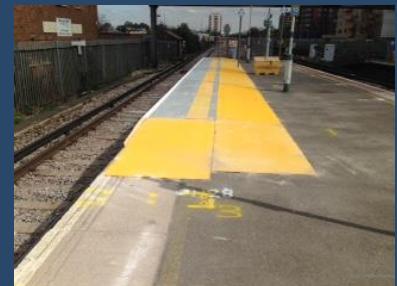
This incident was recently reported in the press following an incident at East Croydon Station.

IP South East's East Croydon platform improvement project has since commenced works to correct the stepping distance, as they begin to install an overlay system from the London End of the platform.

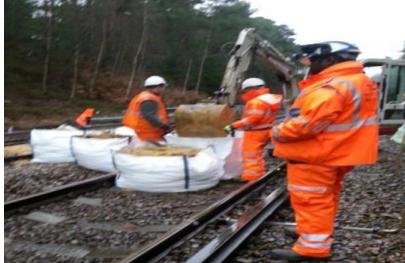
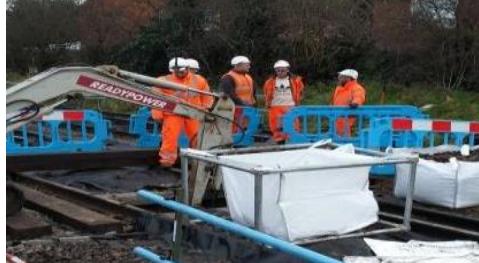
Recent site inspections have identified inadequate segregation of 'men and machine'. This occurred when tonne bags were being filled with waste spoil during UTX activities. Site operatives have been holding the bags either by hand or with a rope, whilst they are filled by the machine.

The pictures below demonstrate what has been seen on occasions and best practice. The bag holder (*on the right*) ensures that operatives always remain a safe distance away from the machine. **You can view the full document here.**

Never enter the agreed exclusion zone, unless directed to by the person in charge.
