Infrastructure Projects Southern

Home Safe

The Southern Region's Weekly Safety Update

18 May 2016

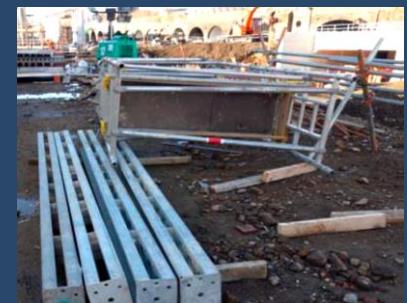
A four metre high mobile scaffold tower was blown over by high winds on the Thameslink programme whilst being stored. The tower struck an operative, causing a small cut to his ear, before striking him on the shoulder. You can find the [full bulletin here](#).

- Storage should be considered during the planning stages of the works to determine locations of storage and identify any specific controls required
- Consider how you are made aware of changing weather conditions and the impact this may have on site

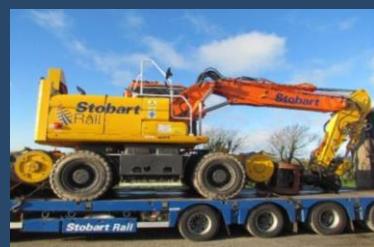
A MEWP operator noticed a problem with the MEWP. In an attempt to reconfigure the MEWP it was taken out of rail mode. As the MEWP Operator lowered the rail wheels remotely from outside of the basket, the brakes failed and the MEWP made an uncontrolled movement.

Minor damage was sustained to the ballast box and to the basket and arm of the MEWP. Fortunately, nobody was injured as there was an exclusion zone in place. The exact cause of the incident is not yet known but there is cause to believe that the brake override switch had been operated which releases the machine brakes. [You can find the full bulletin here.](#)

All Genie Z60 Rail Mounted MEWPs are to be quarantined immediately and subjected to a fleet check to ensure that the emergency override switch is correctly isolated.
