Infrastructure Projects Southern

Home Safe

The Southern Region's Weekly Safety Update

01 June 2016

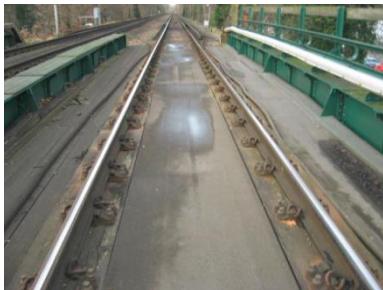
Short cut causes slip

A maintenance operative was carrying out inspections on a timber bridge when he decided to crossover the wet walk boards, rather than walk around the ballast. As he was walking across to the down road, he slipped on the timber and hit his left hip and knee on the running rail.

Due to the wet conditions, this accident could have been a lot more serious. Fortunately, the operative only sustained minor bruising. Slips, trips and falls remain the most common cause of incidents. [You can find the full bulletin here](#).

Always use the identified safe walkways and take extra care in wet weather conditions.

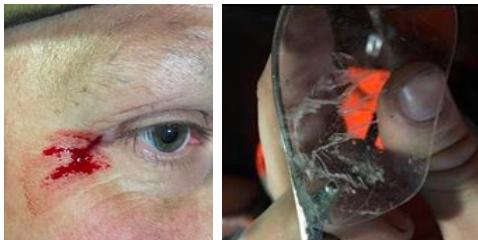
An accident occurred at Appledore during the removal/installation of strail panels, resulting in an eye injury. The team were using an old style ratchet spanner with a new style tie rod; however, the new style ratchet does not locate properly into the end bracket of the tie rod.

The operative had come over to assist another operative with a problematic tie rod and attempted to manoeuvre the rod from the wrong position. He suffered a cut close to his eye, but fortunately, he was wearing safety glasses at the time of the incident which prevented a more serious injury.

During the investigation, it was identified that a number of teams had experienced the same issues with the new tie rods not accepting the ratchet fully, with slippage occurring frequently.

- Close Calls should be raised for potential hazards as soon as you identify them, including faulty equipment
- Always use the correct tools and equipment for the task
