Infrastructure Projects Southern

The Southern Region's Weekly Safety Update

26 October 2016

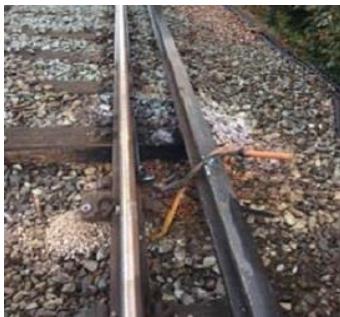
During a possession, members of Orpington Track team were injured when a pair of timber nips came into contact with the third rail within their worksite. They had believed that the third rail was isolated.

The work had not been planned within the usual timeframes, and due to this safety briefings were issued late. The conductor rail within the worksite was partly re-energised; however, the team had not been made aware of the change or the new hazard within the worksite.

One operative sustained a severe arc eye injury and another sustained a bruised ankle and a fractured wrist whilst moving away from the flash over. A third team member's overalls caught fire, but they did not sustain any physical injuries. [You can find the full bulletin here.](#)

- When possession limits and worksite limits change, how do we ensure safety is not compromised and changes are communicated to the relevant parties?
- How do you minimise late changes, and what is your safe 'cut off' point for accepting any changes to a plan?

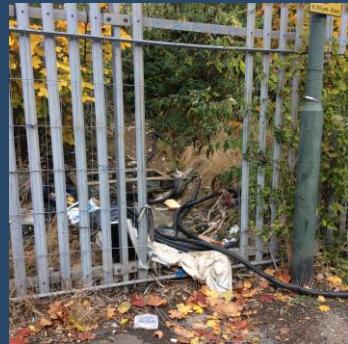
Whilst visiting a site at Slade Green, a Construction Manager noticed a gap in the lineside fencing. The palisade fencing had been removed and a subsequent temporary repair of the fence had also been cut to create an access to a yard to steal cable.

The Construction Manager reported the damage to the fencing to Fault Control who dispatched a Mobile Operations Manager (MOM).

Be vigilant and if they notice any breaches to lineside fencing, report it.
