Safety Flash Report

IP Southern Safety Flash Report 16-54 dated 28 Sep 16

Initial learning from electrical flash-over while erecting Vortok fencing

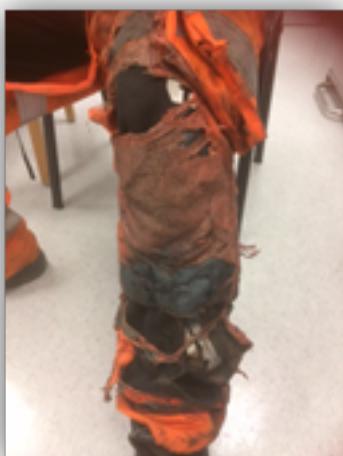
An electrical incident occurred when a team was erecting Vortok fencing under a line block using conductor rail shields for protection from the conductor rail. An insulated shovel came into contact with both the live conductor rail and the running rail causing a short-circuit and an electrical flash-over.

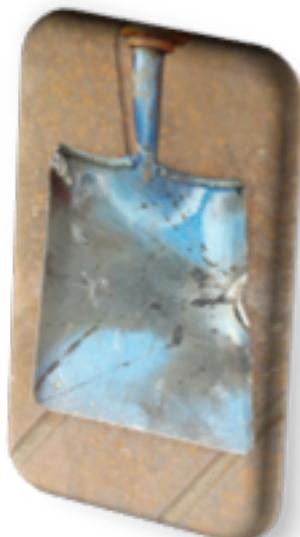
The insulation on the shovel protected the operative from electrocution. Initial reports are that the incident was caused by a slippage but this is still under investigation.

The insulated shovel used

The supplier has stopped this type of activity around the conductor rail until a full review of the incident has taken place. In the meantime, consider reviewing any activity you are undertaking around conductor rails as follows:

- ***Isolation of the conductor rail should be sought in the first instance.*** The electricity at Work Regulations only permits work on or around live conductors when it is unreasonable for it to be dead. We need to challenge whether we have reasonable cause for working on conductor rails that are not dead
- If all other avenues have been exhausted, and it is deemed reasonable for work to take place on or around a live conductor rail, then remember the following:
 - Ensure that the shroud is in a suitable, safe and useable condition and fully covers the third rail leaving no gaps for potential contact points
 - Ensure rubber flaps on the underside of shrouds are sitting correctly on installation
 - Only use insulated tools and equipment and check that the insulating material is not worn and is in a safe useable condition.
