Home Safe

The Southern Region's Weekly Safety Update

09 November 2016

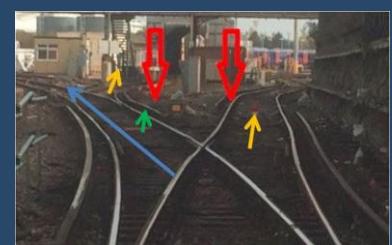
A planned survey was undertaken at Fratton station under a possession. The COSS for the group had been briefed by the ES that all lines were dead. However, he decided to undertake live line checks and a live conductor rail was identified within the worksite. Thanks to the vigilance of the COSS, a potentially dangerous situation was managed and risks mitigated.

The red and green arrows below show the live conductor rails not isolated, with the blue arrow indicating the line under possession. The yellow arrows indicate the lines that are not under possession and not isolated.

When works are planned adjacent to depots, sidings and cross-overs, please ensure that the risk of live lines is considered.

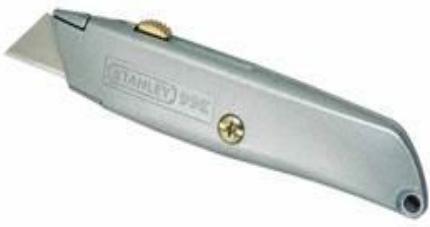
There have been a number of incidents over the years involving operatives being injured whilst using open bladed knives such as Stanley Knives. Earlier this year, a store man working alone lost two pints of blood when he accidentally cut into his hand and severed an artery. This could have had a tragic outcome had someone in an adjacent work site not intervened.

Some parts of the business have banned the use of fixed and manually retractable knives, whilst others rely on risk assessments to ensure the correct tool is used for the correct task. Recent site inspections have identified that fixed or manually retractable knives are currently in use across IP Southern.

Can you eliminate the risk and reduce the use of hand knives from all or part of the task? Or do you specify the right knife for the task being undertaken?

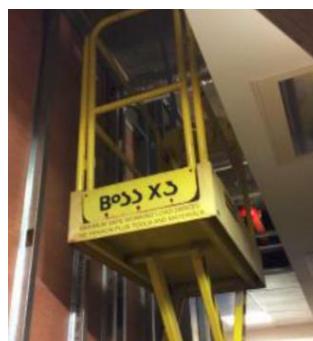
A BoSS X3 powered access platform at Gatwick carried out an uncontrolled ascent to full height beneath a floor slab. Both standard controls and emergency controls failed, and the ascent continued. Once the cradle had reached full height the motor continued to run and began to overheat. The operative in the cradle had to crouch down to avoid impacting the ceiling, bracketry and pipes above. The motor could only be stopped when the supervisor pulled the fuse.

A technical investigation identified that it was due to a battery issue and that an identical failure had occurred in 2013.

Until the manufacturer has provided assurance that these platforms can be used safely, the following models are to be **withdrawn from use immediately; BoSS X2, BoSS X3 and BoSS X3X.**
